4 February 2022

RE: Geotechnical investigation of, proposed Lots 1 & 2 in
subdivision of Lot 128, Cockatoo Crescent, Mullumbimby

GEOTECHNICAL SITE INVESTIGATION

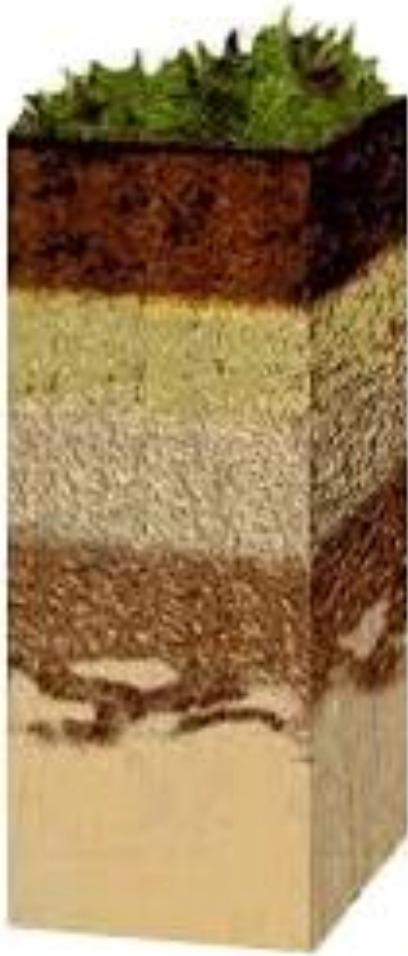
Client : Emma Lappin
Project : Proposed Lot 1 in subdiv Lot 128
Address : Lot 128 COCKATOO CRESCENT, MULLUMBIMBY
Date : 11/01/2022
Location : refer site plan
Borelog : 1 **Ref No :**

0.0		CI	SILTY CLAY FILL: brown, medium plastic, trace of fine gravels, moist.	Soft	1	Disturbed
0.1					1	
0.2		CH	GRAVELLY SILTY CLAY FILL: pale brown, high plastic, moist.	Hard	6

0.3					10	
0.4					10	
0.5					10	
0.6					8	
0.7		CH	SILTY CLAY NATURAL: brown, high plastic, trace of fine gravel, moist.	Hard	5	
0.8					10	
0.9					10	
1.0					12

1.1					8	
1.2					8	
1.3		CI	SILTY CLAY NATURAL: yellow brown, medium plastic, moist.	Hard	10	
1.4					15	
1.5		XW	SANDY GRAVELLY CLAY NATURAL: grey, medium plastic, moist.	Hard	20

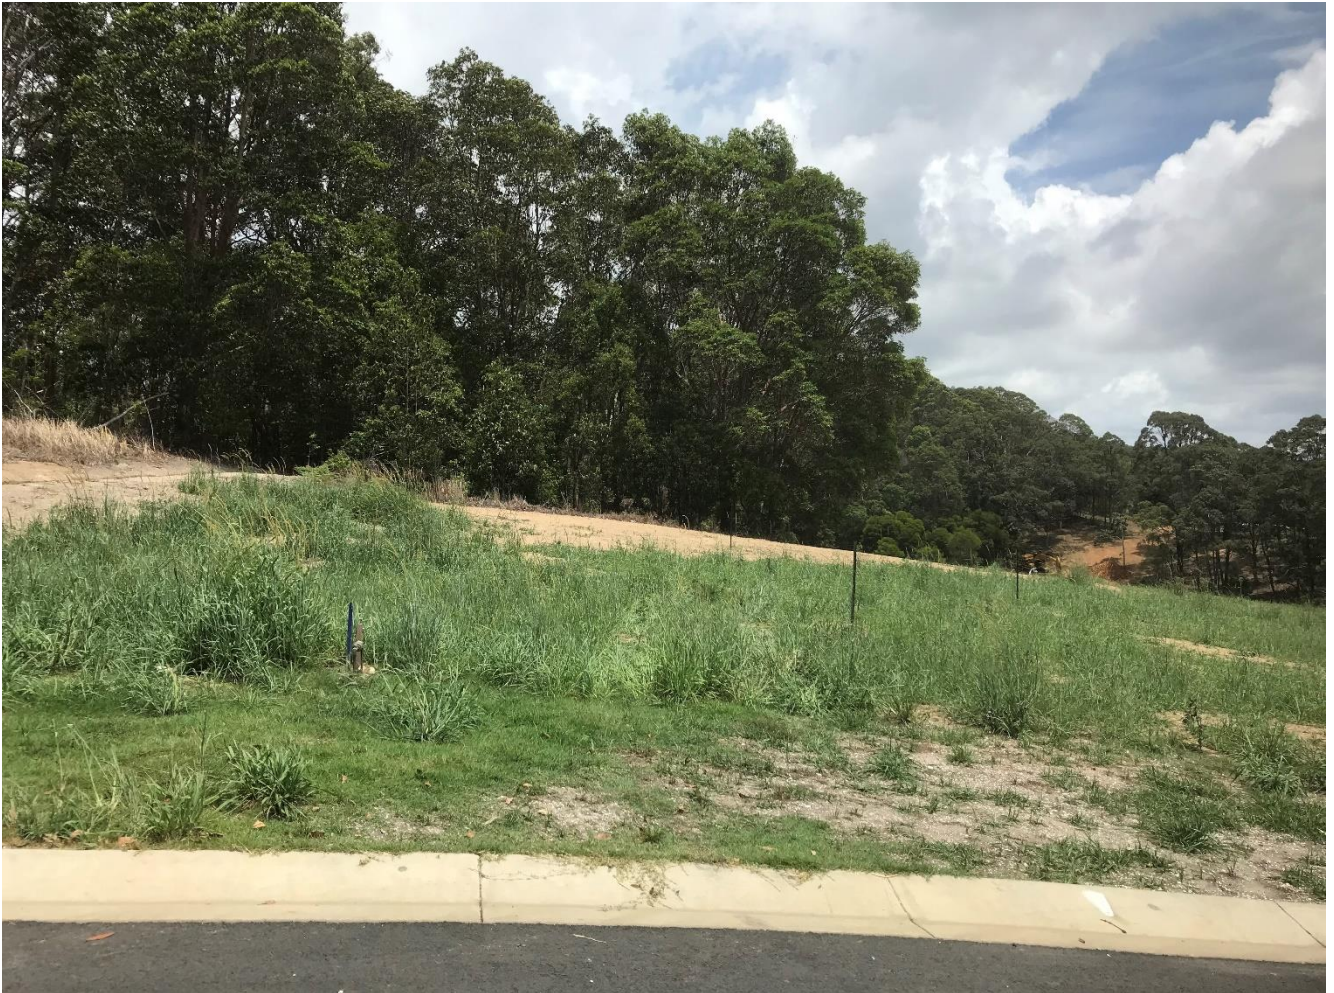
The majority of the site is bare soil and some grass. Significant trees were observed to the rear of the lot which may well affect the site's normal moisture conditions.

View of the site facing a westerly direction.

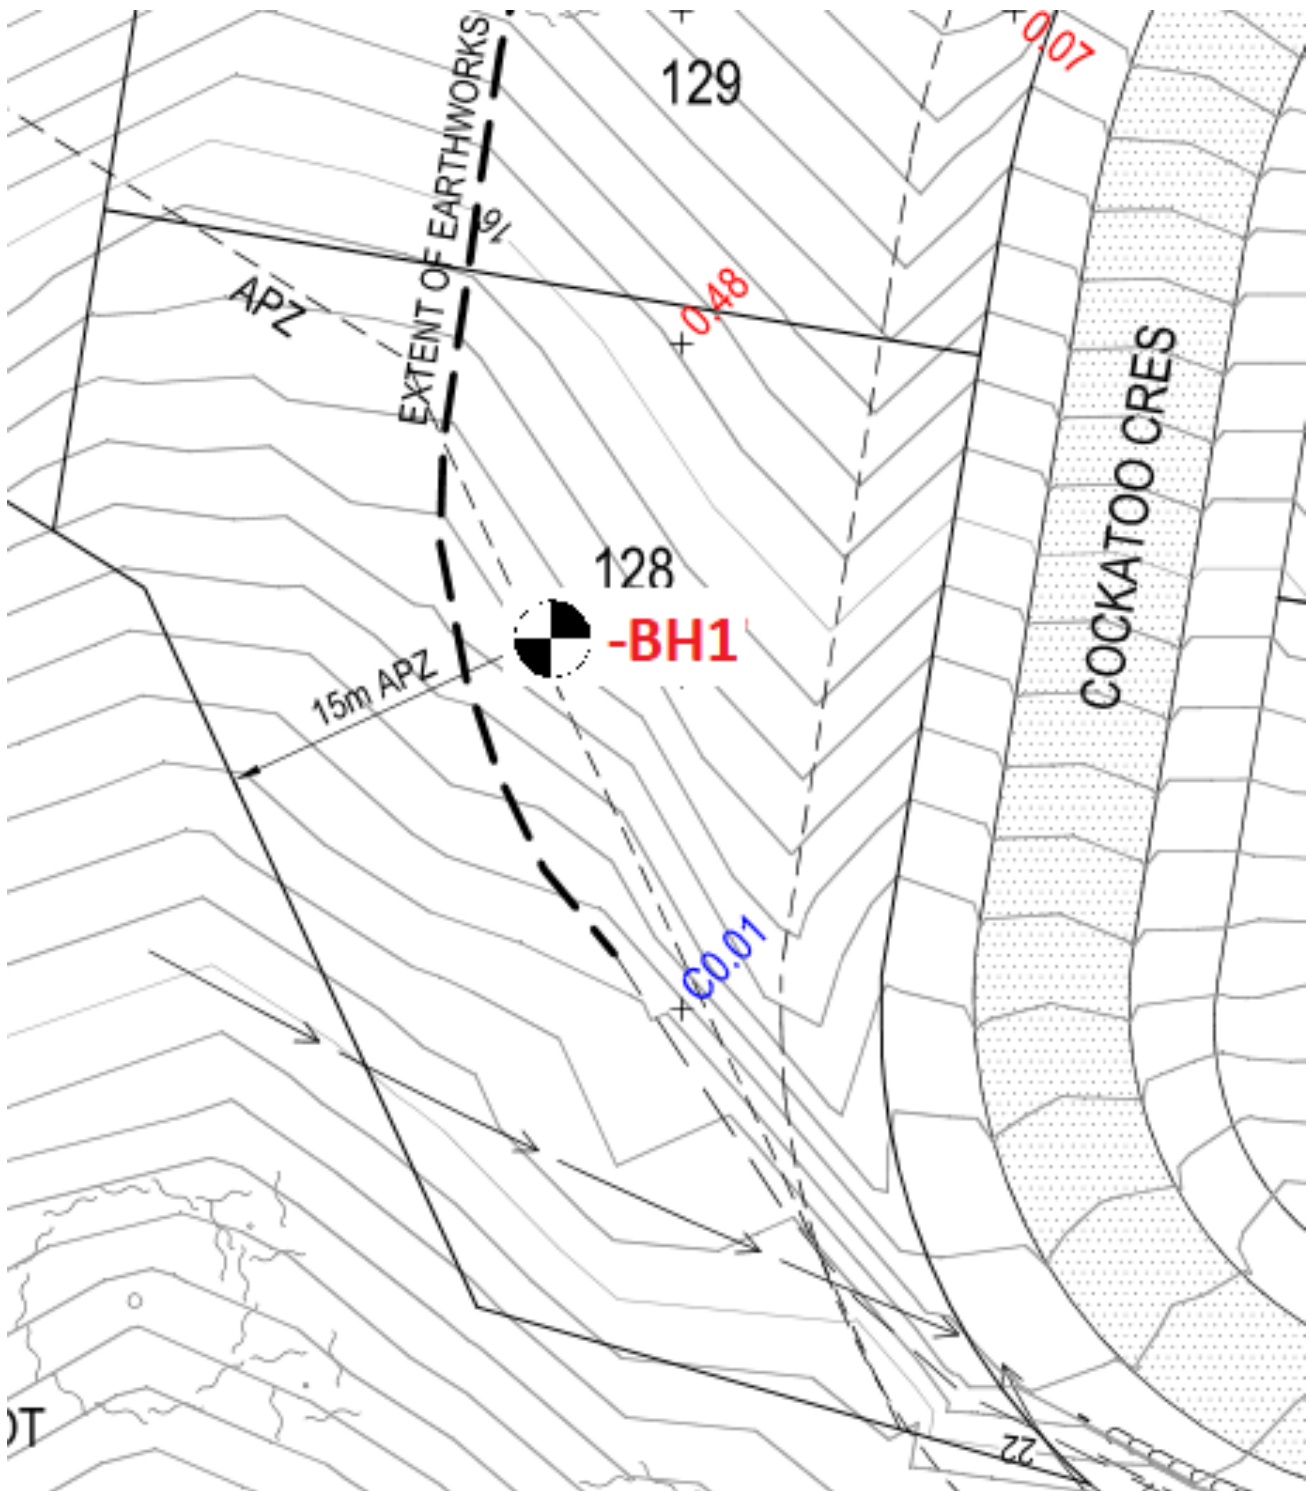
Plan of the site, with ASCT test position.
