Arboricultural Impact Assessment Report

29 Shirley St & 2-4 Milton St, Byron Bay.

Client:
29 Shirley St Pty Ltd

File No: 22014

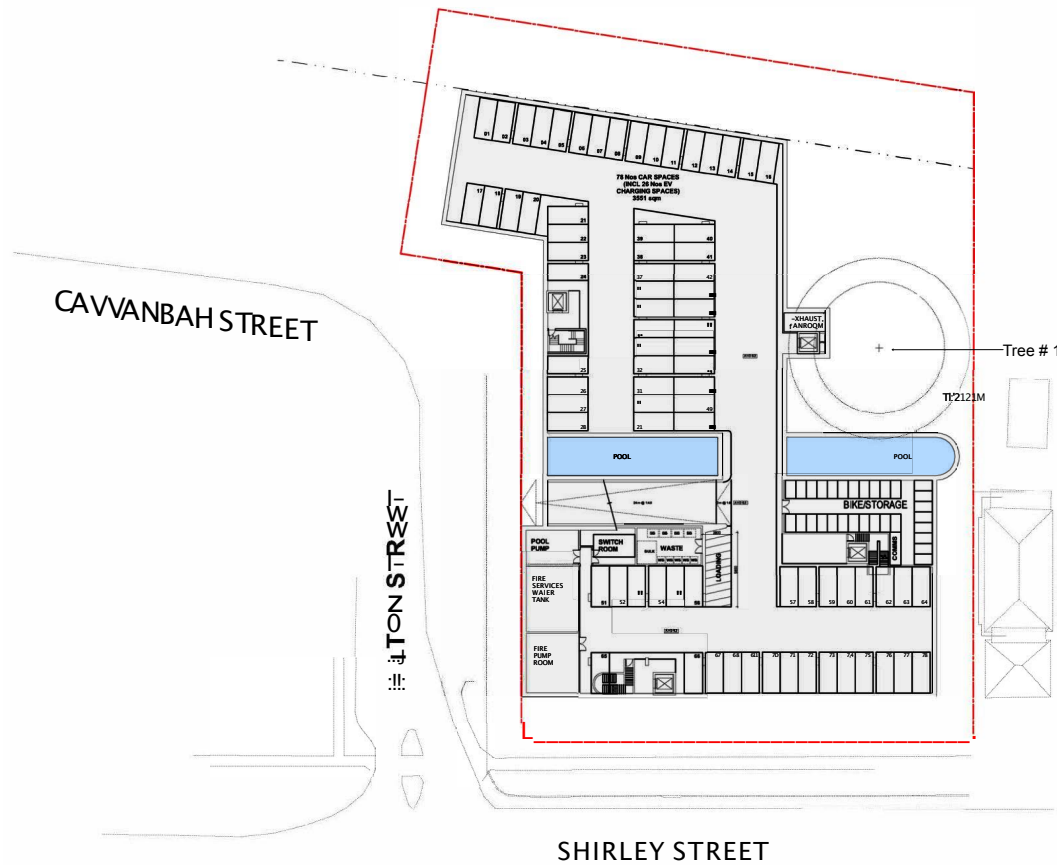
14. Attachment 3 Retained Trees with Basement

7.4 The encroachment of the proposed new building into the TPZ of tree # 1 is calculated to be approximately 30%. This is a major encroachment as defined by the Australian Standard *AS 4970-2009 Protection of trees on development sites. Sect. 3.3.3 Major encroachment*. The Standard allows for major encroachment where it can be demonstrated that the tree will remain viable.

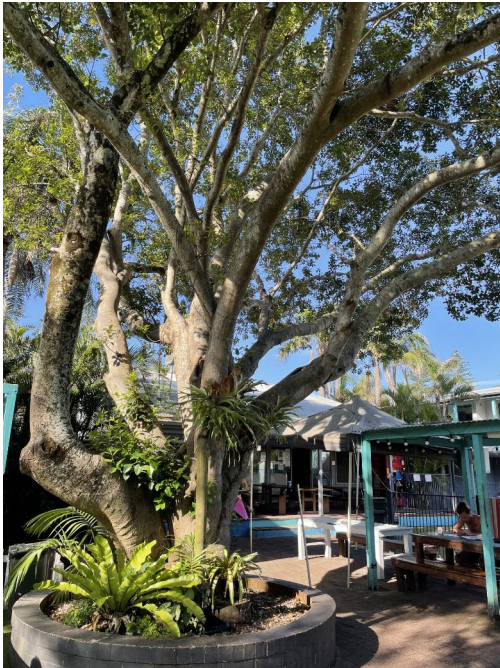
Photo 1. Tree # 1
Fig tree

7.3 It is proposed to retain the Fig tree; tree # 1.

7.6 A 30% encroachment into the TPZ is at the high end of tolerability for retaining the tree in a viable condition. The tree has existing constraints to its root system so not all of the 30% will be lost. This species is very tolerant of root loss and the tree is in good health with good vitality. There is an area contiguous with the existing root system available for the tree to grow additional roots to compensate for the loss of roots due to construction. The construction of the development as planned will not cause this tree to become unviable.

9.1 The trees retained on the site should be protected during construction in accordance with the recommendations of the Australian Standard *AS 4970-2009 Protection of trees on development sites*. The Standard sets out a Tree Protection Zone that is calculated to be an area around the tree with a radius of 12 x diameter at breast height (DBH). The TPZ has a minimum of 2 m and maximum of 15 m. The TPZ should be protected during construction as effectively as is practicable.

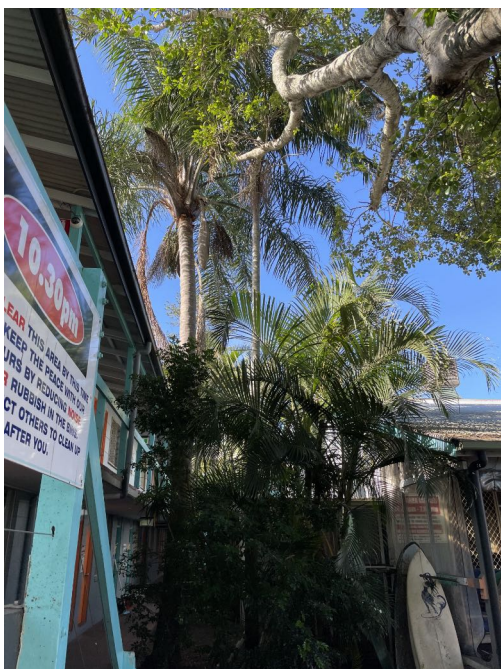
Photo 7.
Most of the trees are exotic species

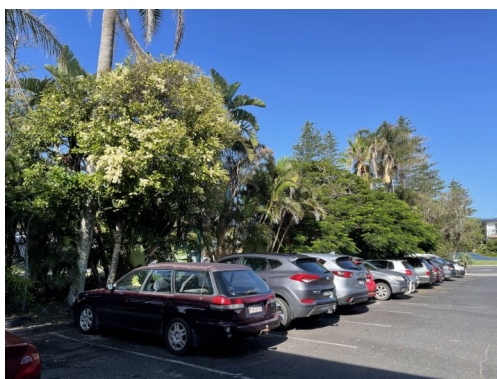
Photo 8.
Garden fronting Shirley St. Exotic species.
