GEOTECHNICAL SITE INVESTIGATION

8 Alooata Crescent, Ocean Shores,
NSW 2483.

ASCT Reference
[H20-1952.](#)

Re: Proposed New Dwelling at 8 Aloota Crescent, Ocean Shores, NSW 2483.

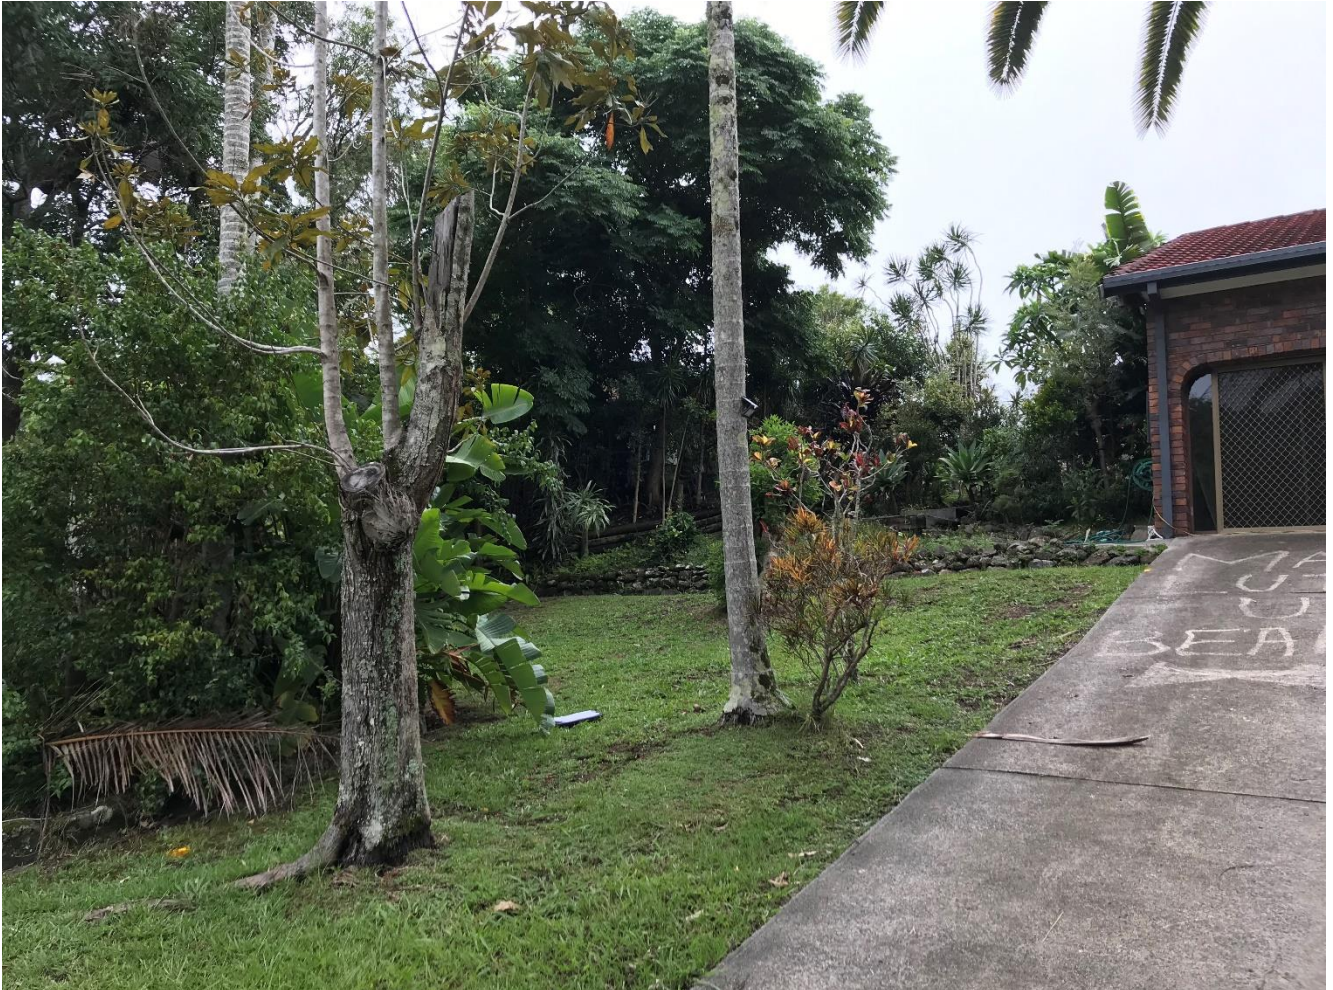
View of the site facing a north easterly direction.

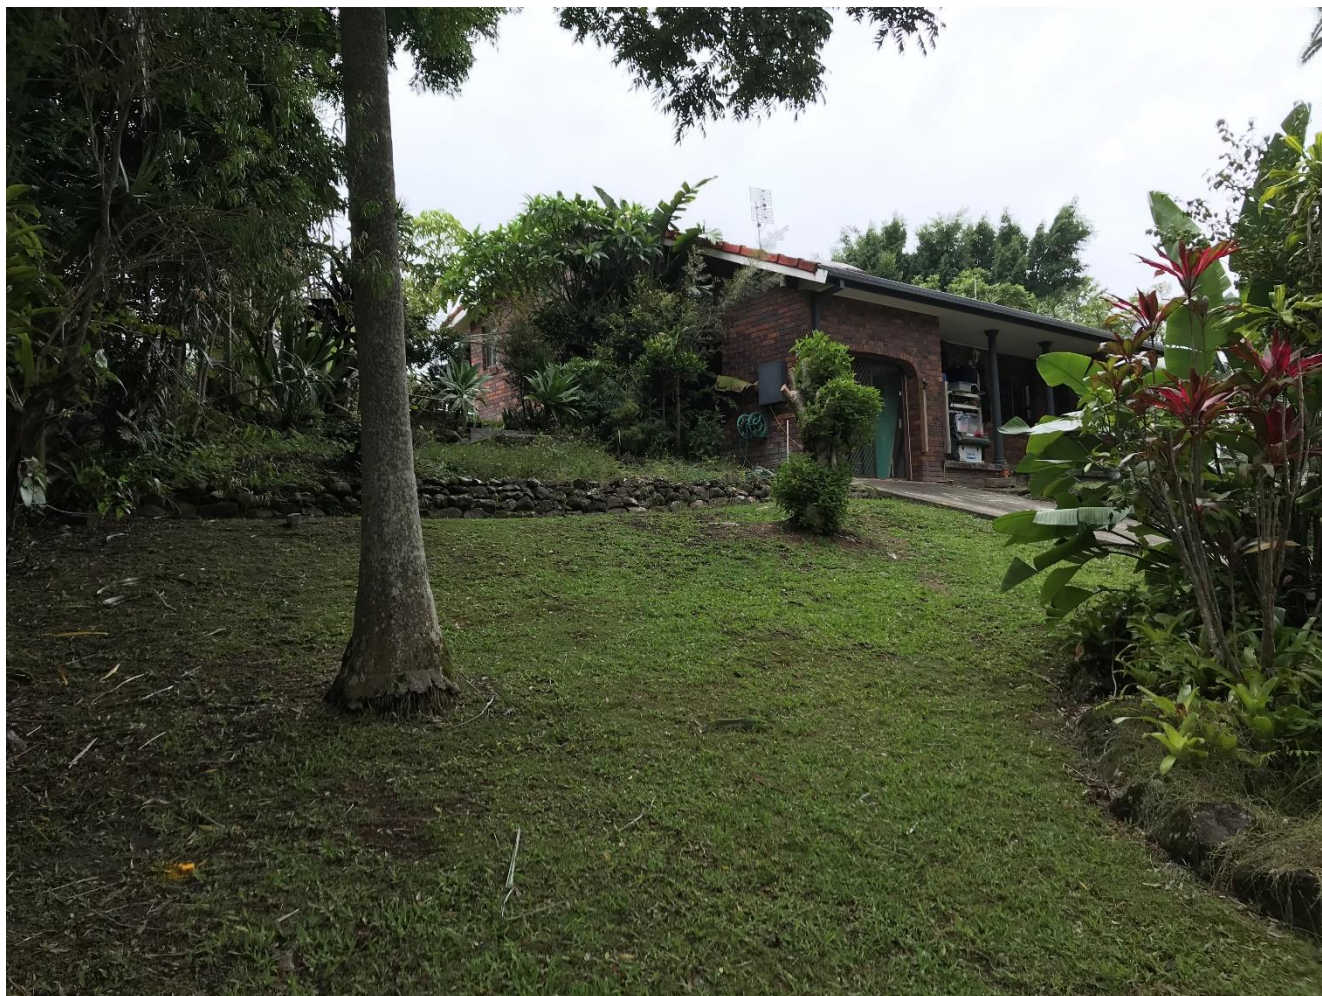
View of the site facing a south easterly direction,

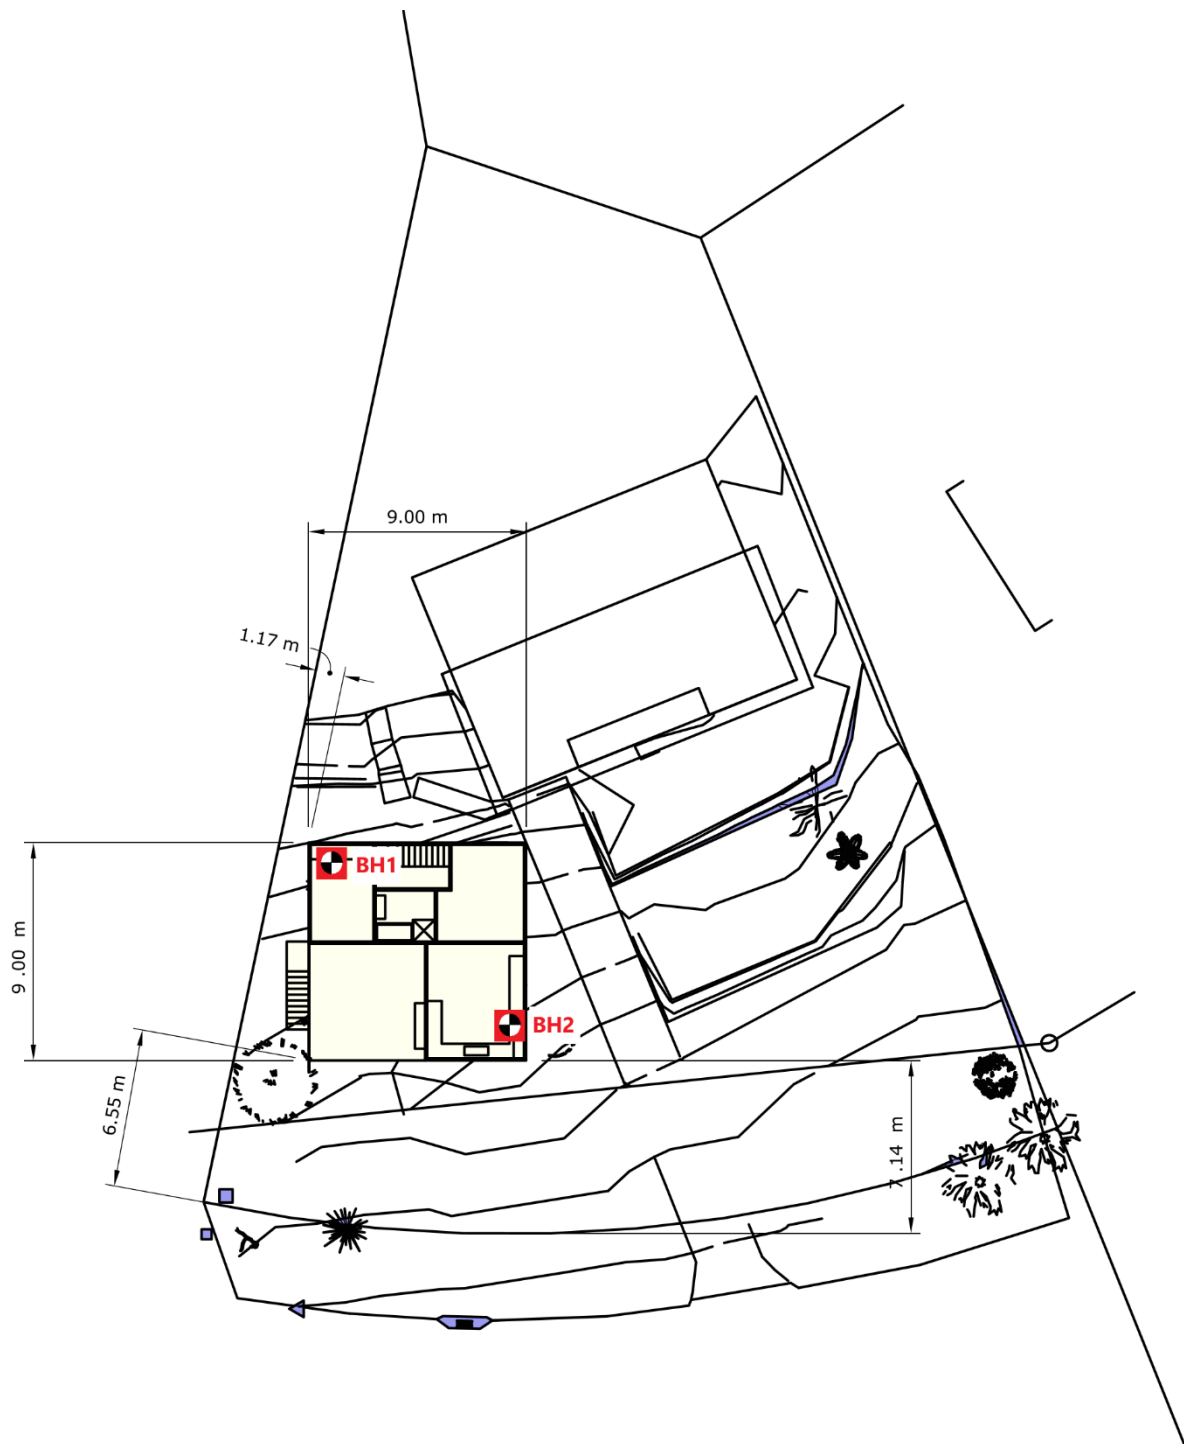
Plan of the site, with ASCT test positions.
