Contamination and Hazardous Building Materials Validation

Date 16/12/2019

10 – 12 Shirley Street Byron Bay NSW 2481

re: Building validation following contamination and hazardous building material remediation

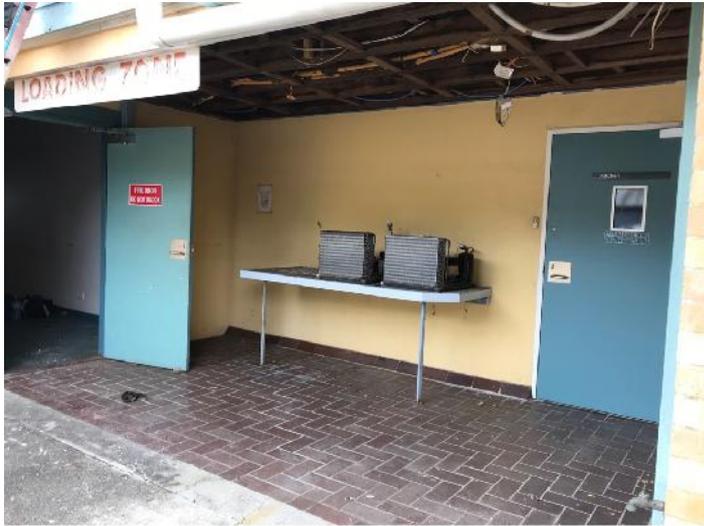
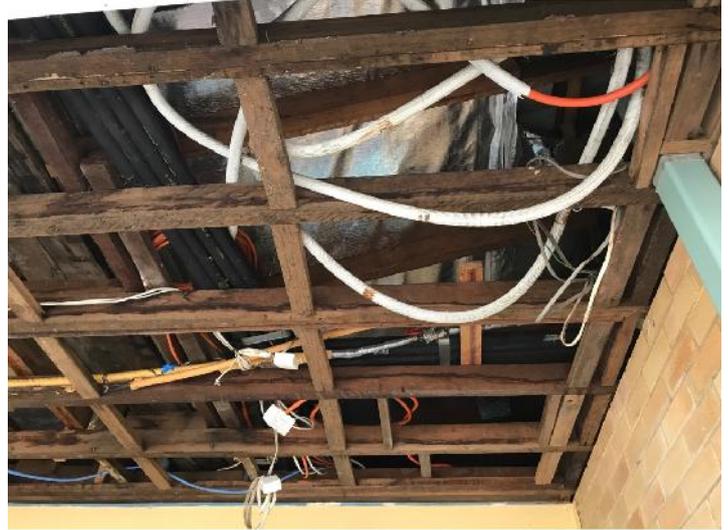
Plate1-2: Loading dock ceiling removed. No visible Ac debris remains

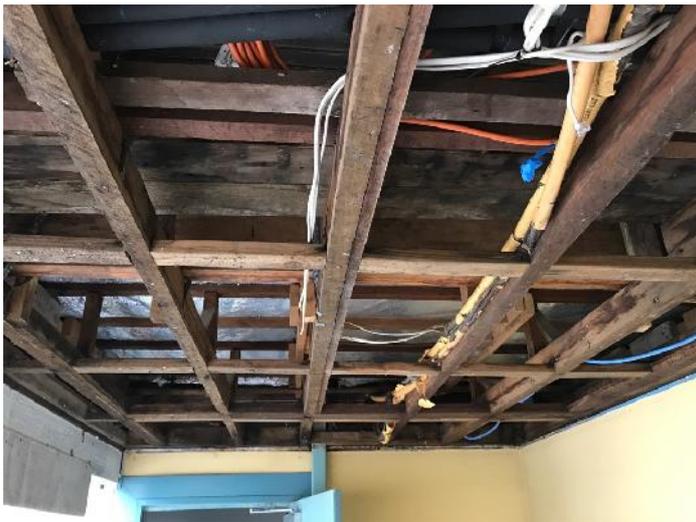
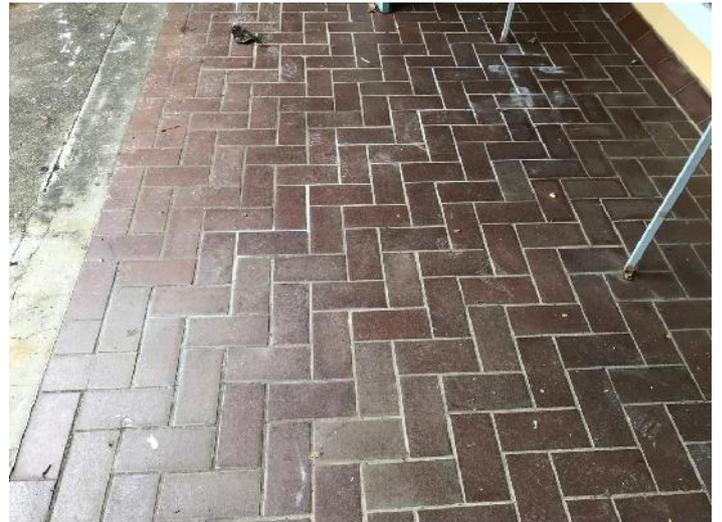
Plate3-4: Loading dock ceiling removed. No visible Ac debris remains on timbers or surface below

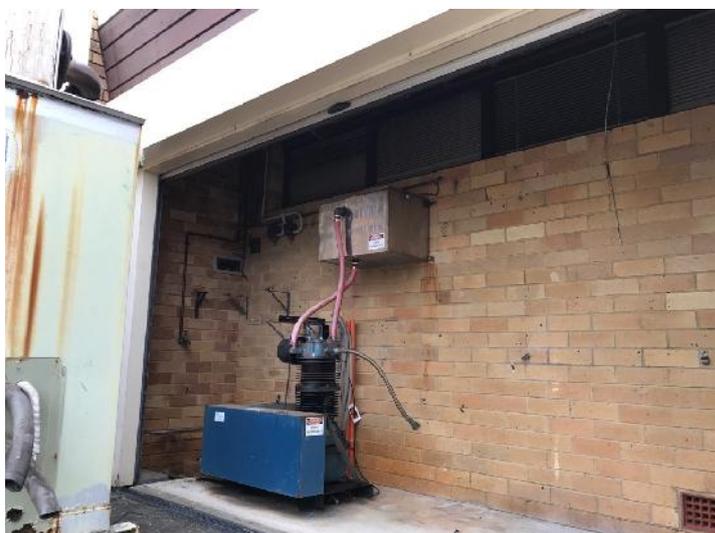
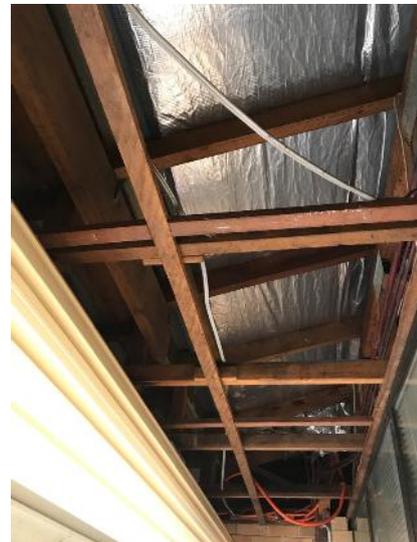
Plate5-6: Eave near old generator removed. No visible AC debris remains

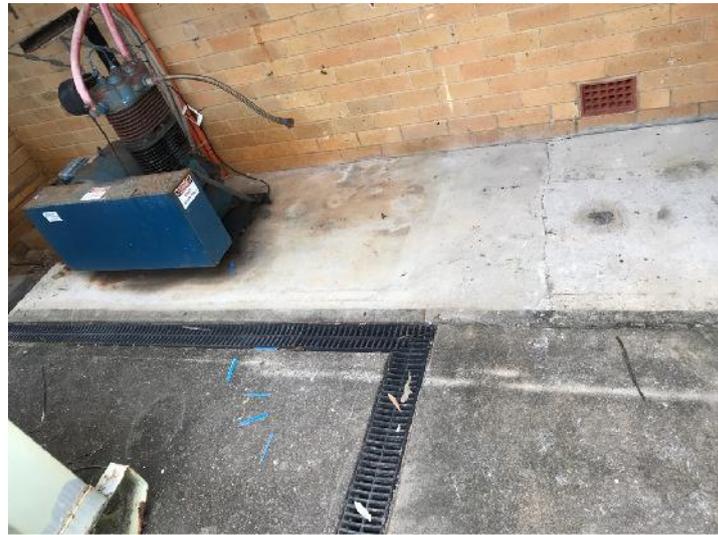
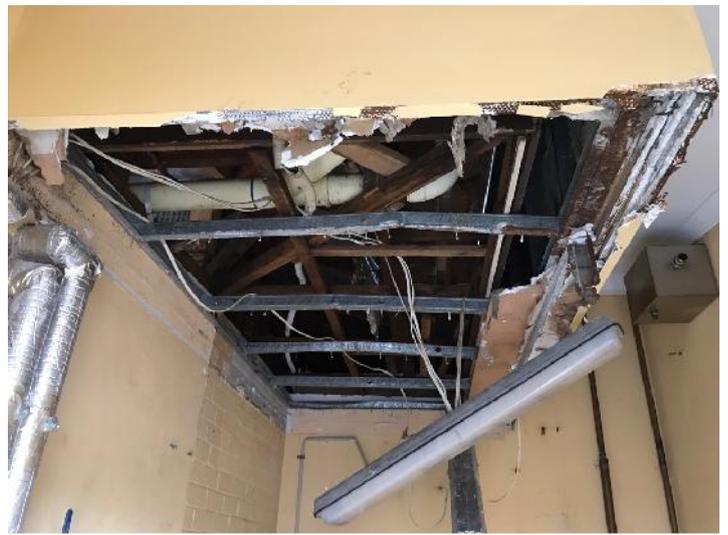
Plate 7-8: Eave near old generator removed. No visible AC debris remains above or below removal zone

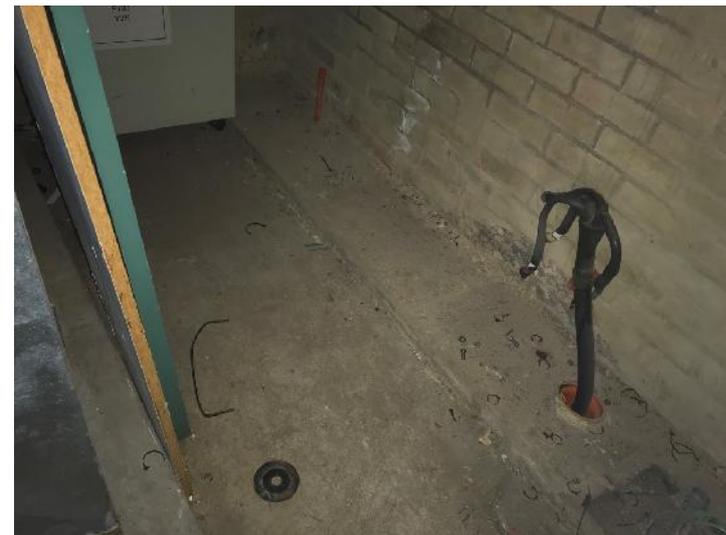
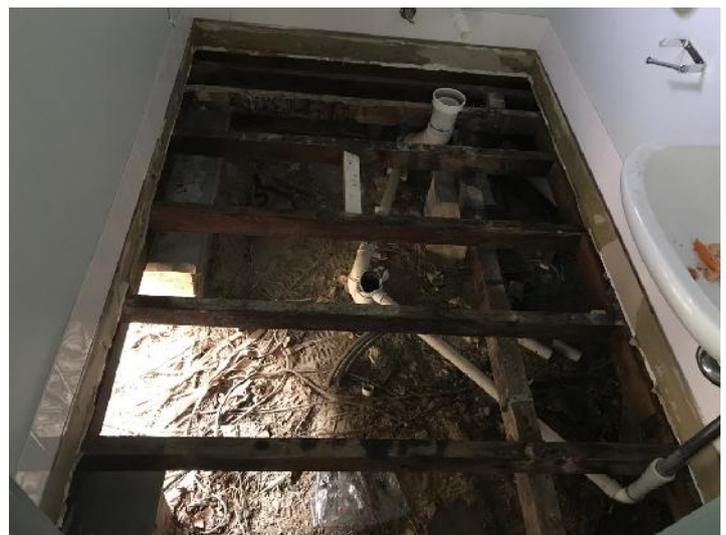
Plate 9: Electrical switchboard removed. Bathroom AC compressed sheeting removed. No visible AC debris remains

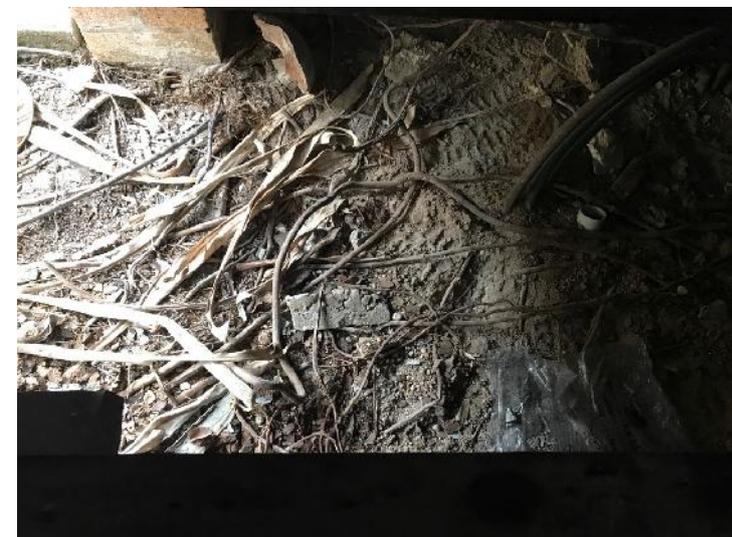
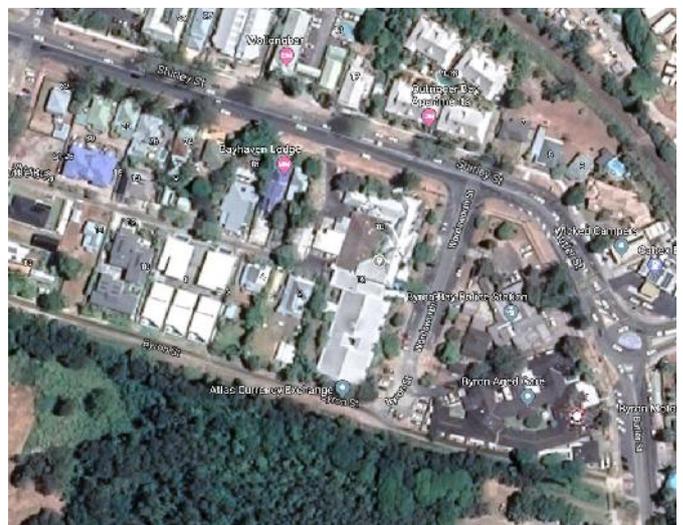
Plate 11: No visible AC debris on surface below removal area. Location

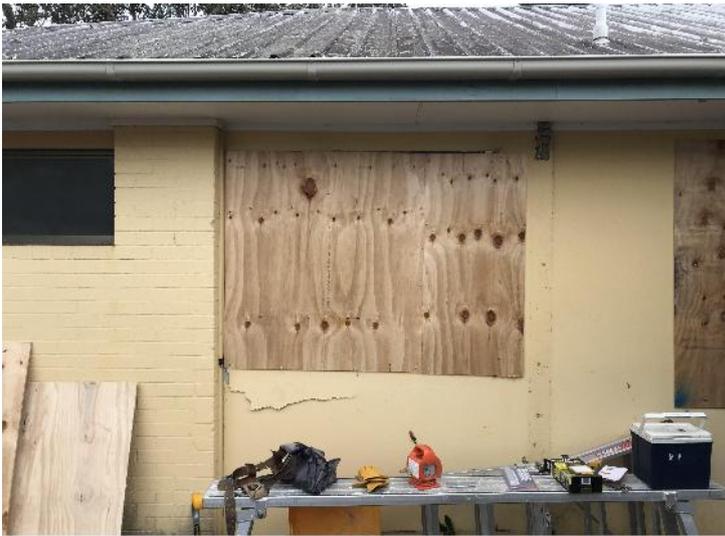
ID1: Both windows containing lead paint systems removed and disposed of.

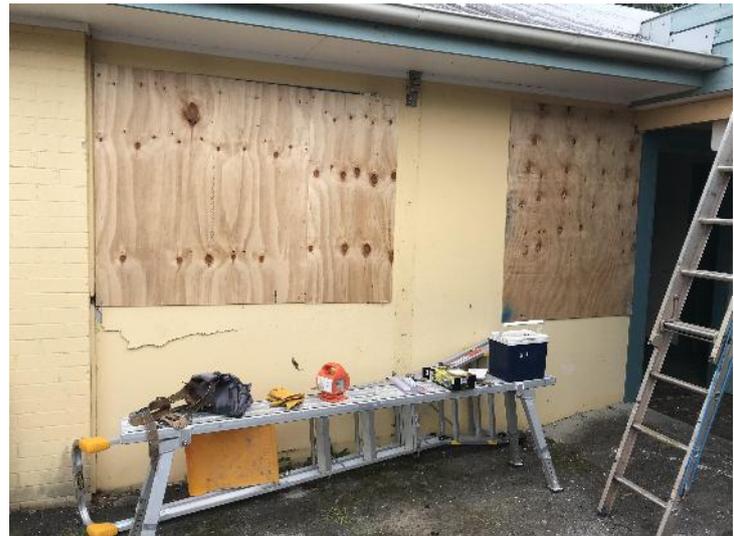
ID2: No visible paint flakes surrounding removal area.

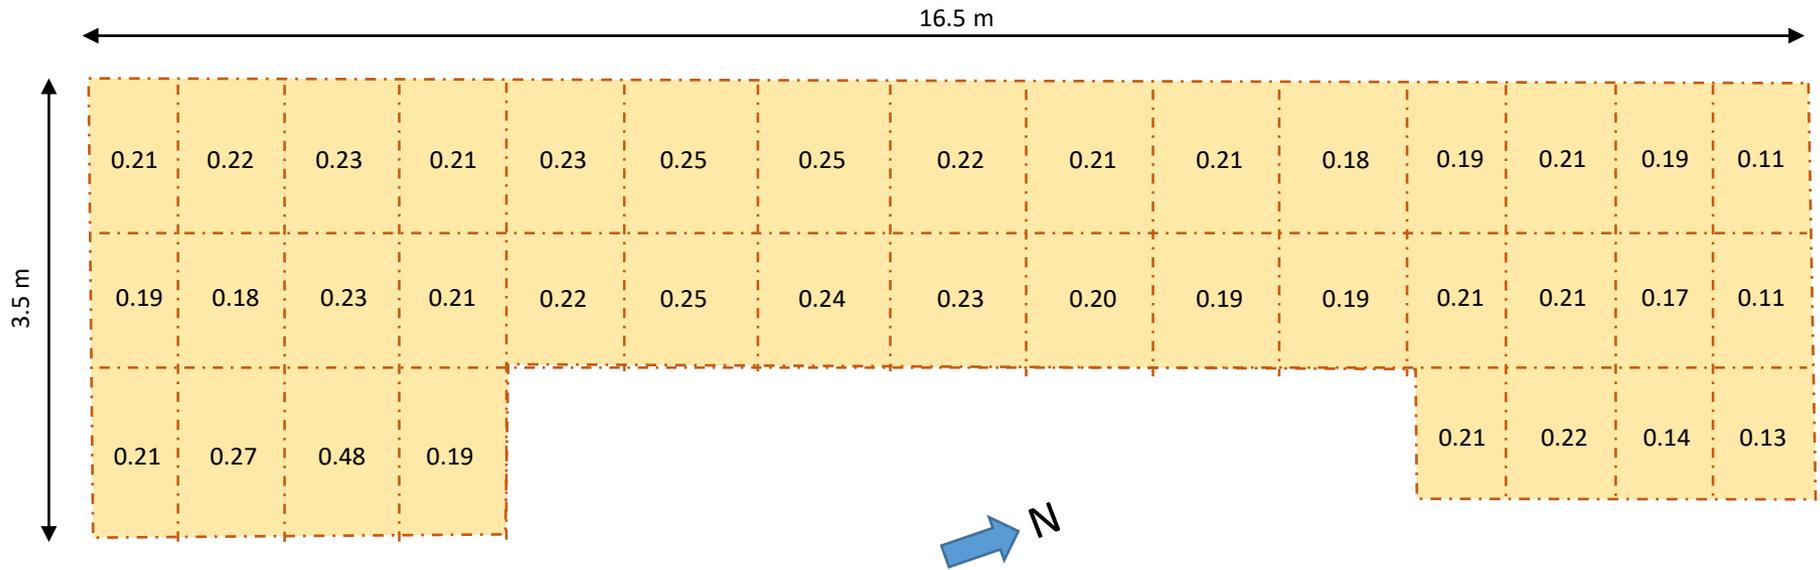
Figure 3 – Radiation Readings
10 – 12 Shirley Street Byron Bay NSW

A radiation survey was undertaken across the area utilising a 'Soeks 0.1M Prime' Gieger counter. An approximate 1 m x 1 m grid was set up over the area to ensure even coverage was achieved, reference to the sample locations can be found in Figure 3, **Attachment 4**. During the survey, radiation levels were measured from approximately 1.0 metre above the concrete slab. Radiation levels were observed between 0.11 and 0.48 $\mu\text{Sv/h}$, with the highest readings noted in the south-east of the area.

On this basis the observed background radiation levels are considered acceptable for commercial use.

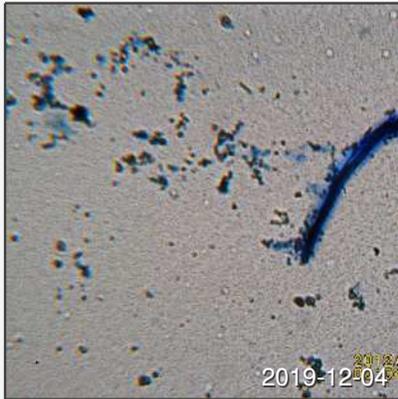
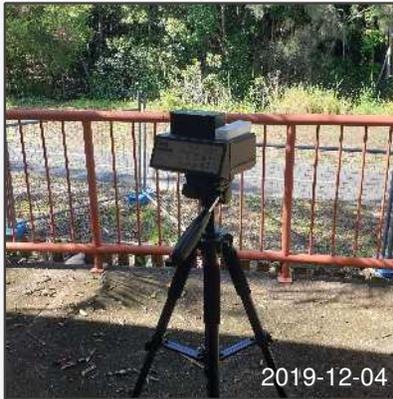
PRV Baseline - Outdoor

A sample was taken of the outdoor air as a benchmark for Rank Ordering. General Identification was not critical as the work scope was not generated via species identification, rather organic loading as affected by known water intrusion points which were identified on the generated Scope of Works. The attached microscopy photo shows the TSC (Total Spore Count) of outdoors on the day. Of note is the high presence of conidiophore, clusters and siliceous material.

This is likely due to two factors.

- 1) Upwind there were bush fire burning causing high levels of pollutants over the past several days. (Bushfires release high levels of conidiophores and other fungal particulate)
- 2) The previous 48 hrs had experienced very strong winds from the same direction.

The TSC was 18920 with general spread being common to outdoors near wild vegetation.

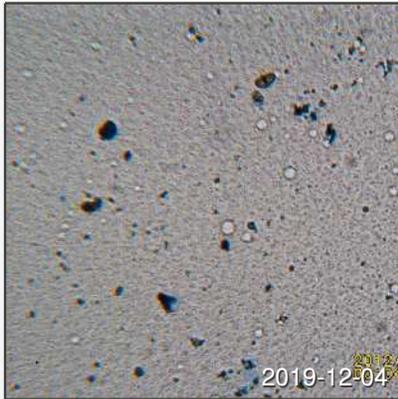
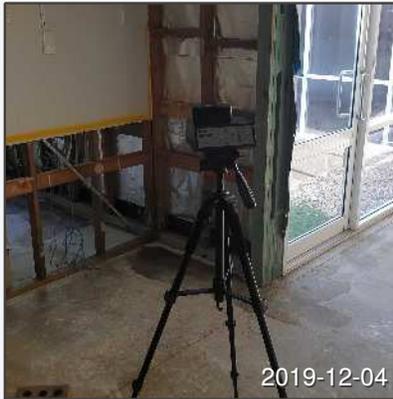
PRV Sample - Block 1

The area around the atrium had previously presented a very high organic load as a result of significant fungal activity on the lower walls and support stud in the office. This area was completely de-lined to remove structure as required. An air sample was obtained near the major works. TSC load was comparable to outdoors and within 10% of the RANK as per the Worldwide Standard for Mould and Bacteria and the Worldwide Standards for Post Remedial Validation. TSC was 21053 with the same genera ordering (Cladosporium). Worthy of note is the high level of potential infiltration to Block 1 with no door seals and it being the most upwind part of the building.

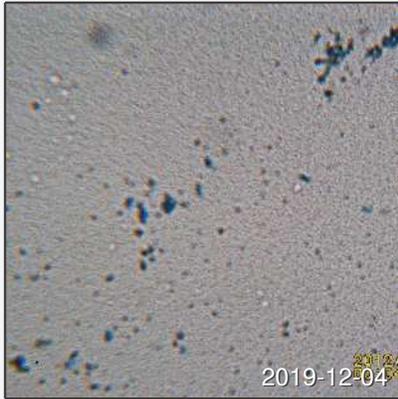
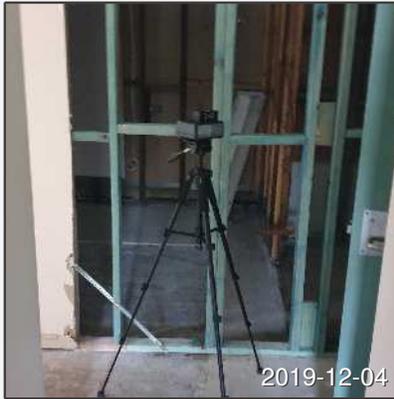
Block 2

The primary remedial works in block 1 related to the records room behind reception and adjacent to the kitchen. This area required significant structural removal and reinstatement to reinforce the structure.

Linings were found to be affected beyond the original scope and these were removed also. The linen storage was also remediated. Sampling was taken from the hall adjacent to the reception. The TSC was 2573; less than 20% of the outdoor sample with the same genera spread and predominant species.

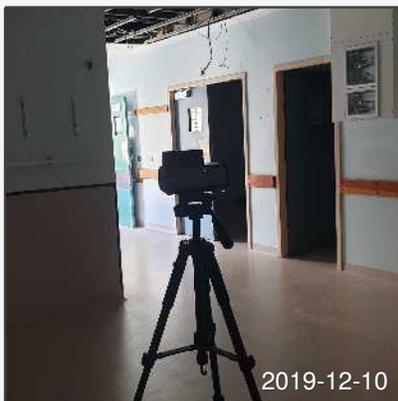
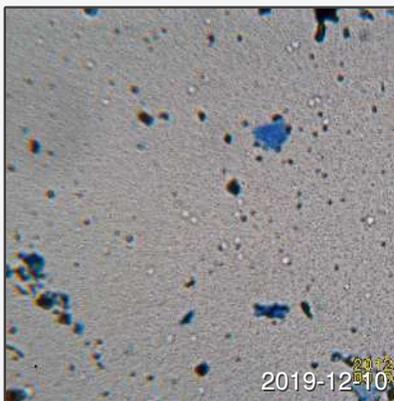
Block 3 - PRV

The primary area of concern was the ceiling where the roof leaked just above the entry to the Emergency Ward. This was removed and cleaned as well as the entire ward.

The TSC was 1280; approximately 8% of that obtained from outdoors with the same Rank Ordering as the outdoor sample.
