Document Ref: BAL2025-0092AA | Rev 0

**RE: PROPOSED POOL**  
**13/174 FOWLERS LANE, BANGALOW**

CMW Geosciences (CMW) was engaged by Kate Barry to carry out a geotechnical investigation for the site located at 13/174 Fowlers Lane, Bangalow. This is for a pool proposed at the site. (refer to Figure 1).

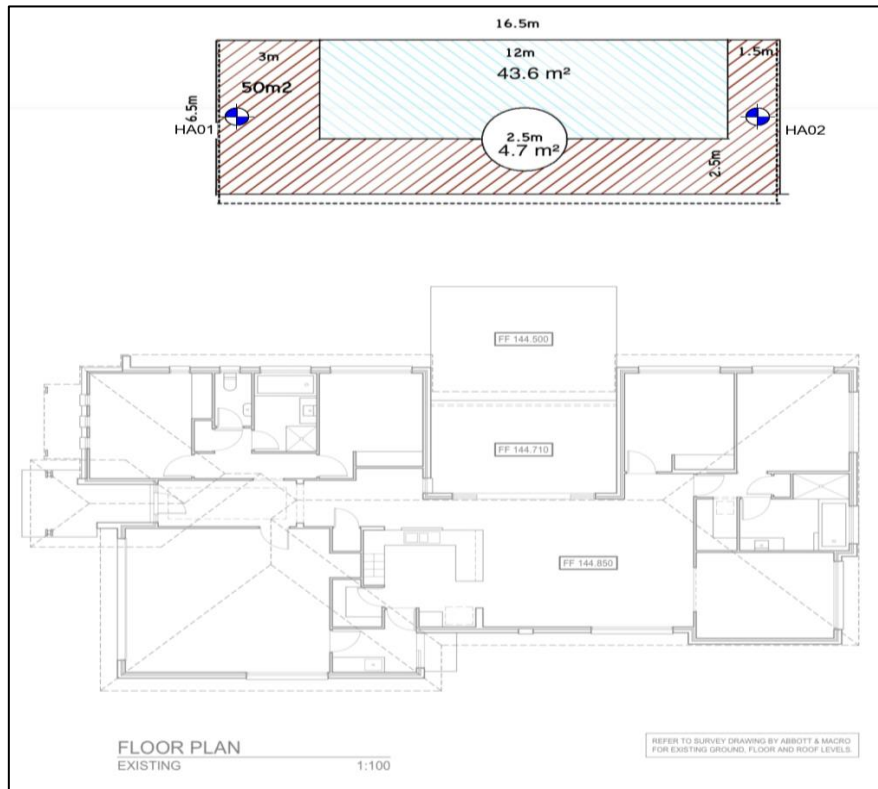
Figure 1: Site Plan with Hand Auger locations overlain. (Courtesy of Kate Barry)

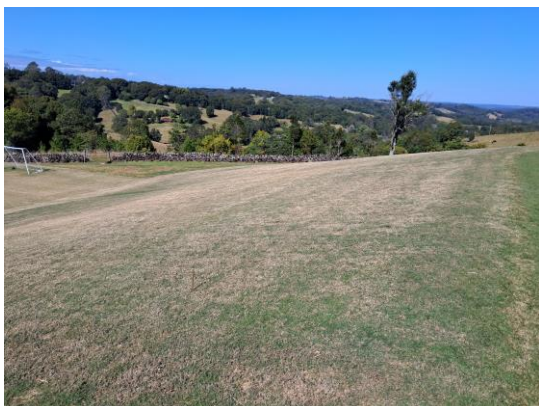
Figure 2 and Figure 3 Indicate the location of the proposed pool is on gently sloped ground surface falling away from the residential structure towards the football field at around 20 degrees. It is understood 'cut and fill' earthworks have occurred to different levels across the site.

Figure 2: Location of the proposed pool

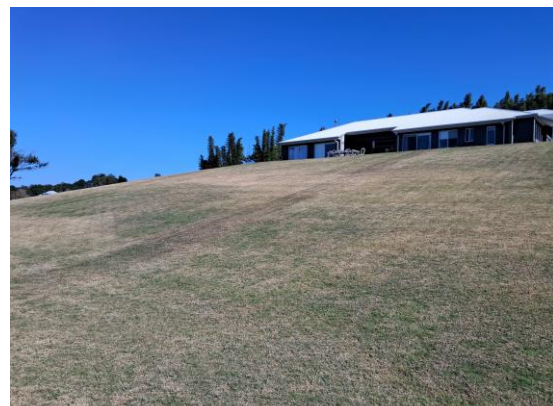
Figure 3: Indication of angle of slope

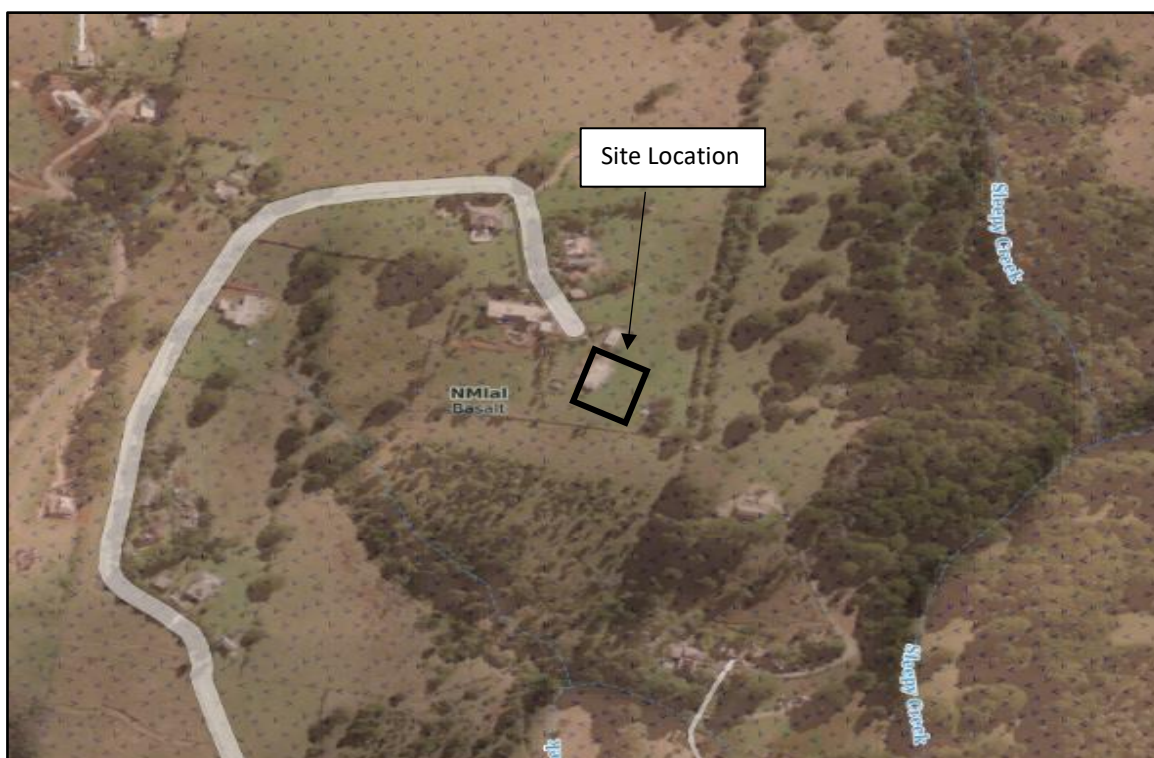
The published geological map for the area presented in Figure 4 shows the site is underlain by the Lismore Basalt. Details of the lithology in the area are provided in Table 1.

Figure 4: Geological Map
