GEOTECHNICAL SITE INVESTIGATION

Prepared by ASCT – Northern Rivers office, for Ben Goad.

1/41 Belongil Crescent, Byron Bay, NSW 2481.

H23-3750.

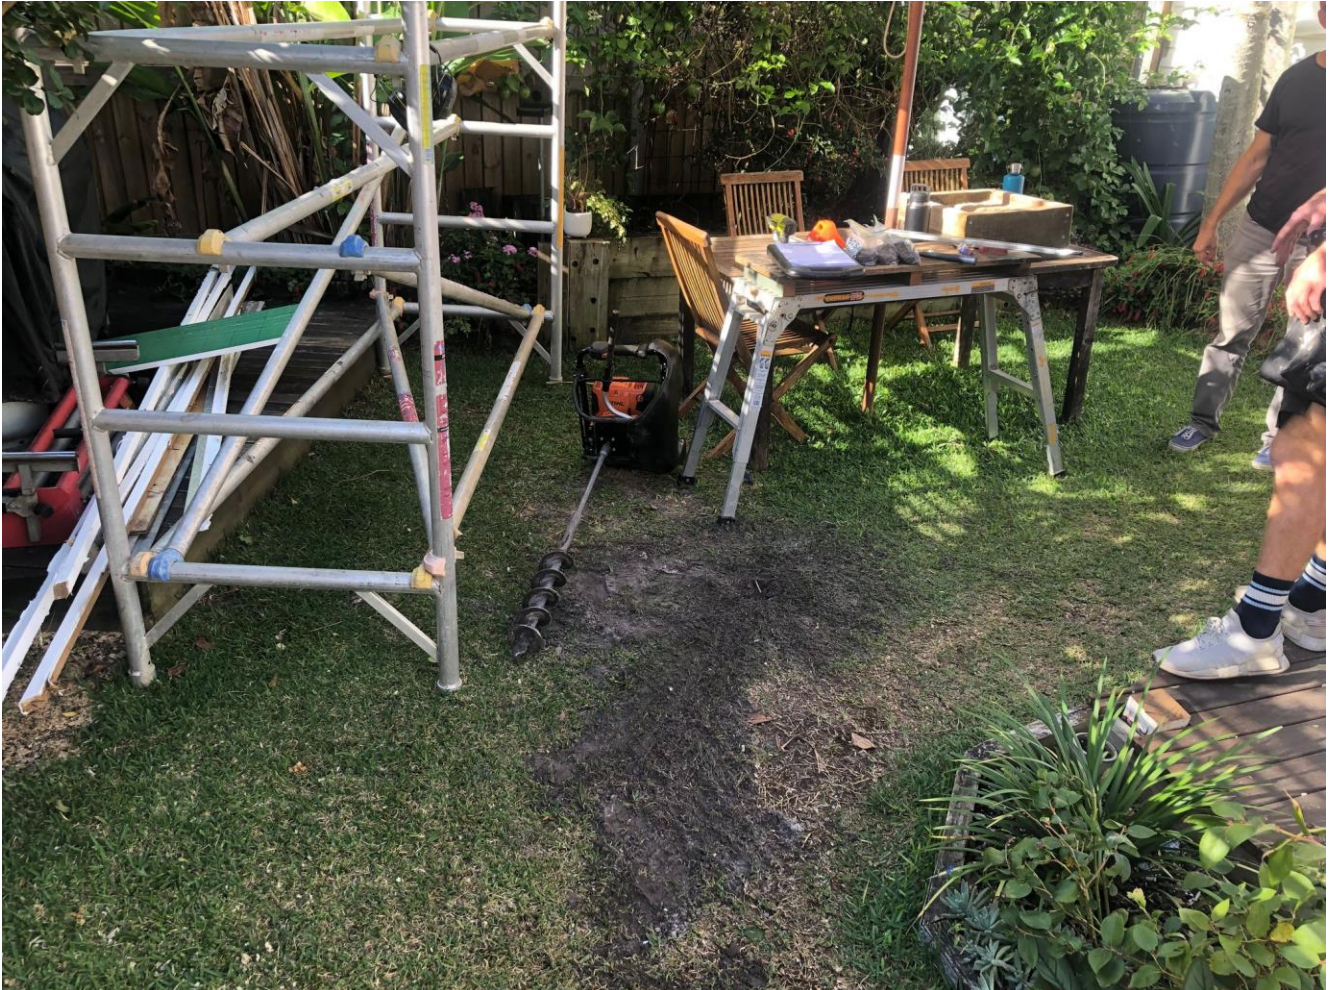
No trees or vegetation which could affect the sites normal moisture conditions were observed.

No significant water sources were observed.

View of the site facing a northerly direction.

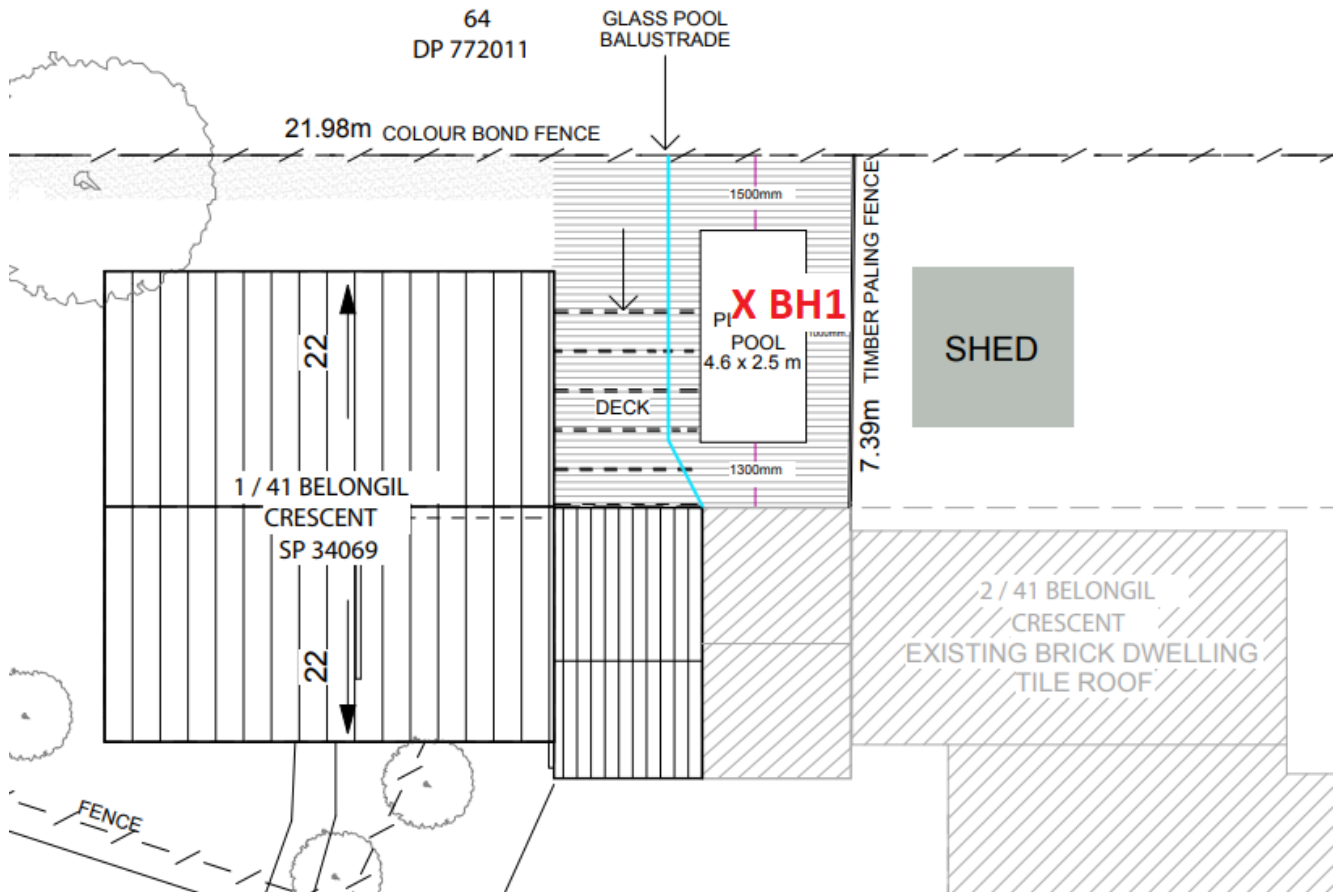
Plan of the site, with ASCT test positions.
