Northern Tree Care

Re: 9 Fingal St Brunswick Heads.

Underground Service Locations
Site Report/Site Details

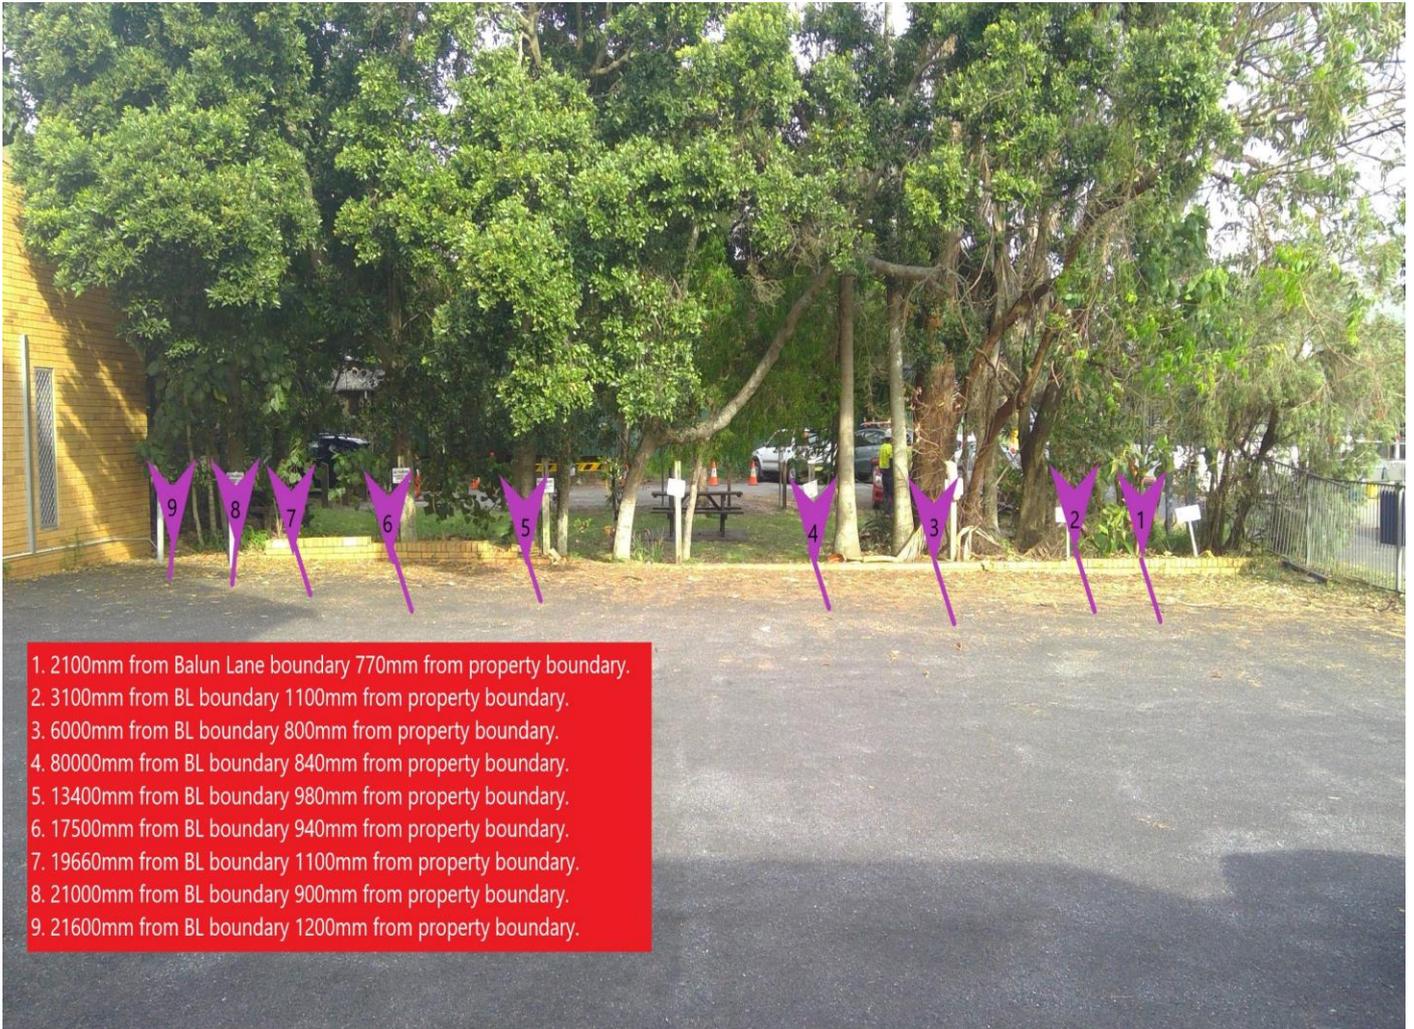
The GPR survey was carried out by Lambert Locations on 25th September 2022. Their report is attached. The survey showed 9 roots crossing the boundary. They were between 20 and 30 mm in diameter and went from 800 to 1,200 mm into the carpark. The distance into the carpark is the distance the roots were large enough to be picked up by the radar, so larger than 10 mm in diameter.

GPR scan only conducted to map possible tree root systems. (D)
