GEOTECHNICAL SITE INVESTIGATION

SUBJECT SITE

1931 Coolamon Scenic Drive, Mullumbimby, NSW 2482.

H23-3770.

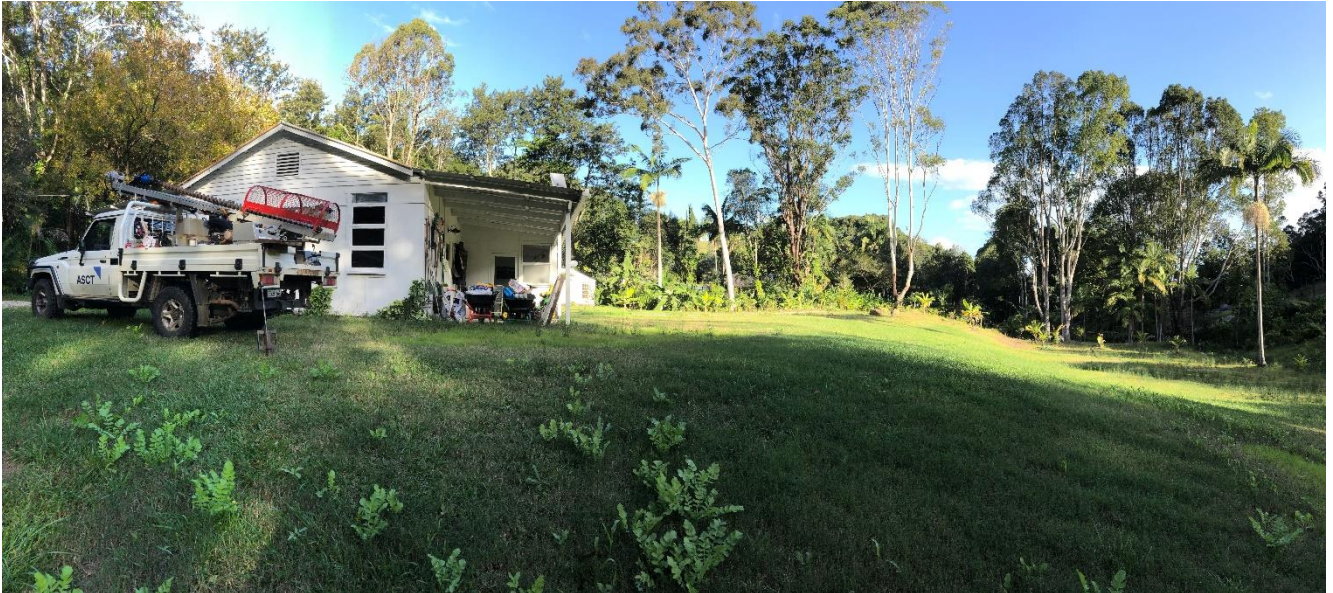
View of the site facing a south easterly direction.

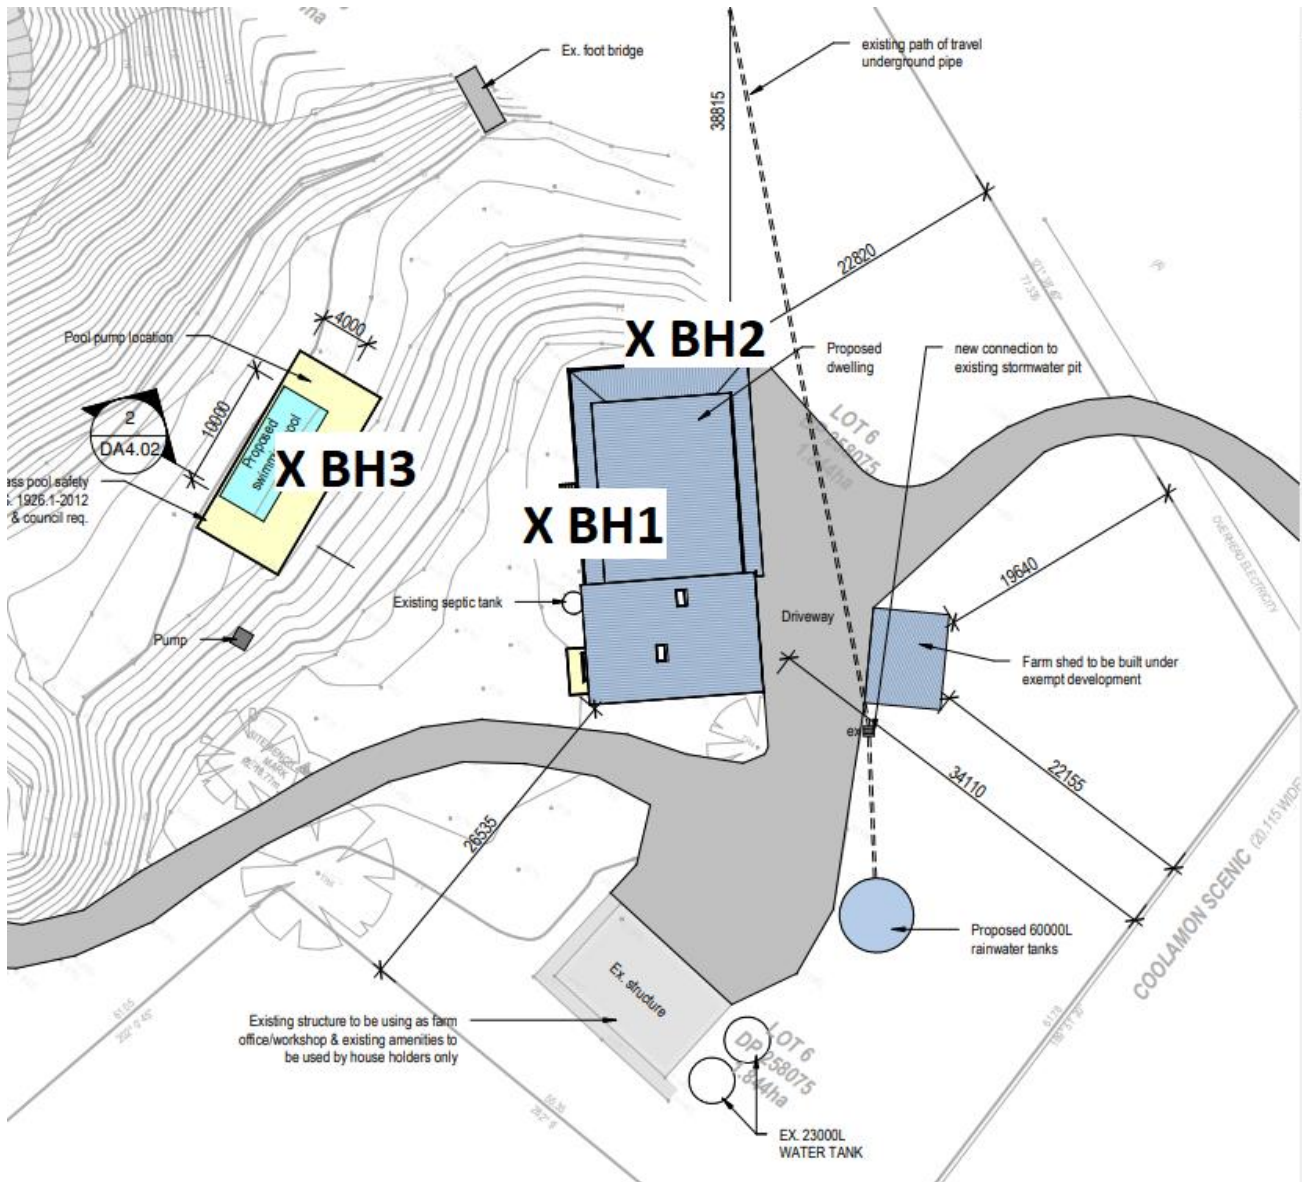
Plan of the site, with ASCT test positions.
