Arboricultural Impact Assessment Report

I Kendal St Byron Bay

File No: 2321
Version:
14 Nov 2023

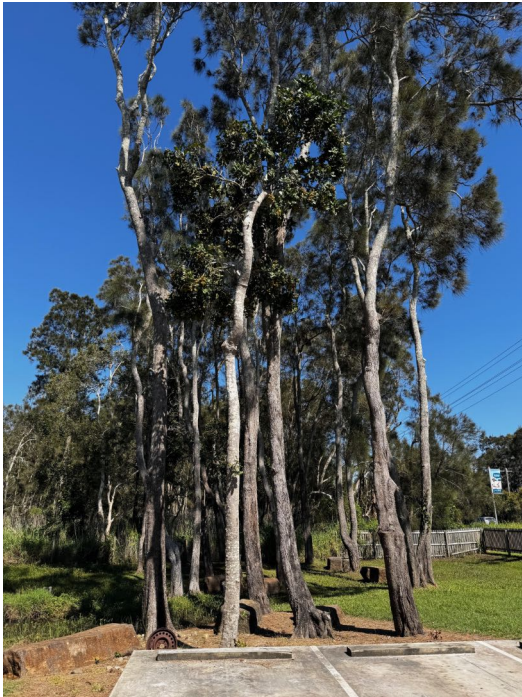
Photo 1. Trees # 1 ~ 5

7.1 The trees # 1 ~ 5 are growing beside a concrete parking area. This concrete pad has been in place for some years. The proposed new units will be built on the footprint of the existing concrete pad. There will be no additional encroachment into the TPZ of these trees from the new development. The theoretical encroachment into the TPZ and SRZ of these trees is shown in Table 2 Encroachments. The actual encroachment is negligible however and will not cause any of these trees to become unviable.

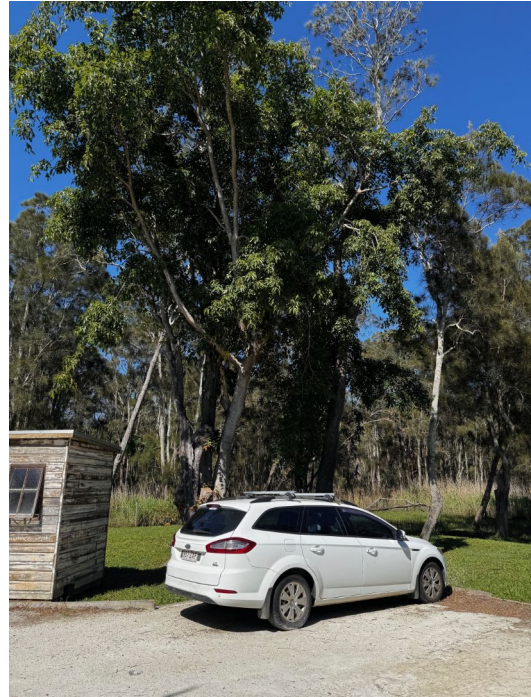
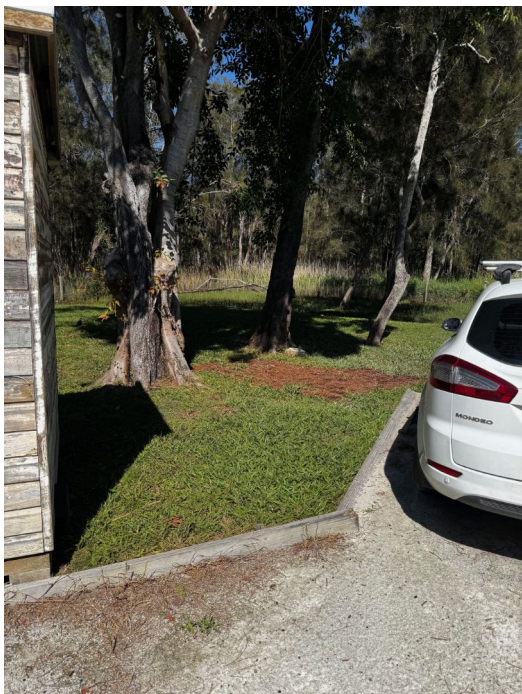
Photo 2. Trees 6 ~ 9

7.2 Trees # 6 ~ 9 are growing close to an area of carparking that has a gravel surface. This area is proposed to be expanded slightly for a new driveway and Unit 19 is proposed to be built close to these trees. The theoretical encroachment into the TPZ of these trees is shown in Table 2 Encroachments. The theoretical encroachment for trees # 6, 8 and 8 are major encroachments according to the Australian Standard *AS 4970-2009 Protection of trees on development sites. Sect 3.3.4 Major encroachment*. The considerations detailed in the Standard Sect. 3.3.4 Encroachment considerations are assessed in Tables 3, 4 and 5 Encroachment Considerations.

AS 4970 Section 3.3.4 Encroachment considerations		Considerations for this tree
a	Location and distribution of roots to be determined through non destructive investigation methods.	No investigation of root locations has been undertaken. As the existing driveway has been in place for several years it is unlikely that there are structural roots growing under the gravelled area. There are likely to be some roots growing in the additional area affected by the proposed development.
b	The potential loss of root mass resulting from the encroachment.	The theoretical encroachment into the TPZ and SRZ of this tree is 38%. However most of this area is already covered by a gravel carpark. The actual additional encroachment is small. The work proposed will be on top of the existing soil grade and will not result in the destruction of significant amounts of existing roots.
c	Tree species and tolerance to root disturbance.	Fig trees are a very hardy species and tolerant of root disturbance and root loss.

d	Age, vigour and size of the tree	The tree is a young mature tree that is growing beside and strangling a She Oak tree. The tree is vigorous and medium sized.
e	Lean and stability of the tree	The tree is leaning away from the proposed new building and carpark. It is strangling the She Oak tree next to it. It is very stable.
f	Soil characteristics	The soil is sandy and the water table is high. The trees roots are not expected to grow very deeply in this location due to the high water table.
g	The presence of existing or past structures	As noted there is an existing gravel carpark near the tree.
h	Design factors	The units and carpark have been designed to give as much clearance to the tree as is practicable.

AS 4970 Section 3.3.4 Encroachment considerations		Considerations for this tree
a	Location and distribution of roots to be determined through non destructive investigation methods.	No investigation of root locations has been undertaken. As the existing driveway has been in place for several years it is unlikely that there are structural roots growing under the gravelled area. There are likely to be some roots growing in the additional area affected by the proposed development.
b	The potential loss of root mass resulting from the encroachment.	The theoretical encroachment into the TPZ is 43% and SRZ of this tree is 28%. However most of this area is already covered by a gravel carpark. The actual additional encroachment is small. The work proposed will be on top of the existing soil grade and will not result in the destruction of significant amounts of existing roots.
c	Tree species and tolerance to root disturbance.	She Oak trees are a moderately hardy species and tolerant of root disturbance and root loss.

d	Age, vigour and size of the tree	The tree is a mature aged tree that is growing beside and is being strangled by a Fig tree. The tree is moderately vigorous and medium sized.
e	Lean and stability of the tree	The tree is leaning away from the proposed new building and carpark. It is being strangled the Fig tree next to it. It is likely to be killed by the Fig tree in the next 15 ~ 20 years. If this occurs it will be held in place by the Fig tree and is unlikely to fall over.
f	Soil characteristics	The soil is sandy and the water table is high. The trees roots are not expected to grow very deeply in this location due to the high water table.
g	The presence of existing or past structures	As noted there is an existing gravel carpark near the tree.
h	Design factors	The units and carpark have been designed to give as much clearance to the tree as is practicable.

AS 4970 Section 3.3.4 Encroachment considerations		Considerations for this tree
a	Location and distribution of roots to be determined through non destructive investigation methods.	No investigation of root locations has been undertaken. As the existing driveway has been in place for several years it is unlikely that there are structural roots growing under the gravelled area. There are likely to be some roots growing in the additional area affected by the proposed development.
b	The potential loss of root mass resulting from the encroachment.	The theoretical encroachment into the TPZ is 25% and SRZ of this tree is 3%. However most of this area is already covered by a gravel carpark. The actual additional encroachment is small. The work proposed will be on top of the existing soil grade and will not result in the destruction of significant amounts of existing roots.
c	Tree species and tolerance to root disturbance.	She Oak trees are a moderately hardy species and tolerant of root disturbance and root loss.

d	Age, vigour and size of the tree	The tree is a mature tree. The tree is moderately vigorous and medium sized.
e	Lean and stability of the tree	The tree is leaning away from the proposed new building and carpark. The tree is stable.
f	Soil characteristics	The soil is sandy and the water table is high. The trees roots are not expected to grow very deeply in this location due to the high water table.
g	The presence of existing or past structures	As noted there is an existing gravel carpark near the tree.
h	Design factors	The units and carpark have been designed to give as much clearance to the tree as is practicable.

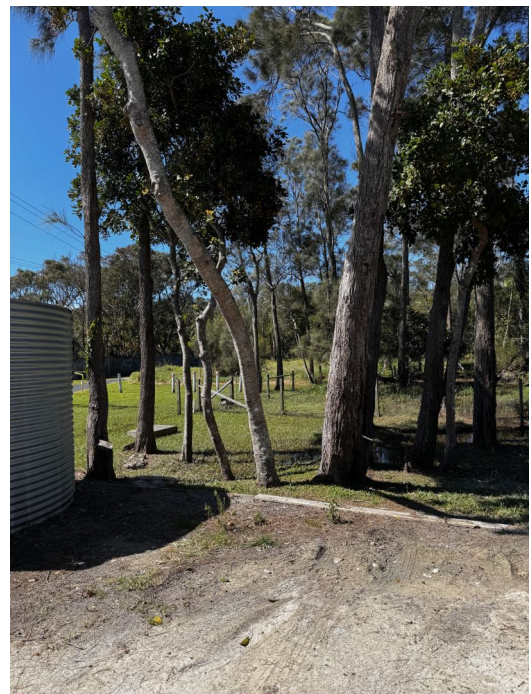
Photo 4. Trees # 10 ~ 16

7.3 Trees # 10 ~ 17 are growing close to a proposed car parking space and Unit 20. There is an existing gravel carpark in this area. The most easterly carpark will be slightly extended and the footprint for Unit 20 will also be extended to the south beyond the current carpark footprint. There will be a theoretical major encroachment for trees # 10, 11 , 14, 15 and 16 shown in Table 2. Encroachments. The considerations detailed in the Standard *Sect. 3.3.4 Encroachment considerations* are assessed in Tables 6, 7, 8, 9 and 10 Encroachment Considerations.

AS 4970 Section 3.3.4 Encroachment considerations		Considerations for this tree
a	Location and distribution of roots to be determined through non destructive investigation methods.	No investigation of root locations has been undertaken. As the existing driveway has been in place for several years it is unlikely that there are structural roots growing under the gravelled area. There are likely to be some roots growing in the additional area affected by the proposed development.
b	The potential loss of root mass resulting from the encroachment.	The theoretical encroachment into the TPZ is 26% and SRZ of this tree is 26%. However most of this area is already covered by a gravel carpark. The actual additional encroachment is small. The work proposed will be on top of the existing soil grade and will not result in the destruction of significant amounts of existing roots.
c	Tree species and tolerance to root disturbance.	She Oak trees are a moderately hardy species and tolerant of root disturbance and root loss.

d	Age, vigour and size of the tree	The tree is a mature tree. The tree is moderately vigorous and medium sized.
e	Lean and stability of the tree	The tree is leaning away from the proposed new building and carpark. The tree is stable.
f	Soil characteristics	The soil is sandy and the water table is high. The trees roots are not expected to grow very deeply in this location due to the high water table.
g	The presence of existing or past structures	As noted there is an existing gravel carpark near the tree.
h	Design factors	The units and carpark have been designed to give as much clearance to the tree as is practicable.

AS 4970 Section 3.3.4 Encroachment considerations		Considerations for this tree
a	Location and distribution of roots to be determined through non destructive investigation methods.	No investigation of root locations has been undertaken. As the existing driveway has been in place for several years it is unlikely that there are structural roots growing under the gravelled area. There are likely to be some roots growing in the additional area affected by the proposed development.
b	The potential loss of root mass resulting from the encroachment.	The theoretical encroachment into the TPZ is 10% and SRZ of this tree is 3%. However most of this area is already covered by a gravel carpark. The actual additional encroachment is small. The work proposed will be on top of the existing soil grade and will not result in the destruction of significant amounts of existing roots.
c	Tree species and tolerance to root disturbance.	Tuckeroo trees are a very hardy species and tolerant of root disturbance and root loss.

d	Age, vigour and size of the tree	The tree is a mature aged tree. The tree is being suppressed by the presence of the She Oak trees growing in the close vicinity. The tree is vigorous. It is small for its age due to the suppressing effect of the She Oak trees.
e	Lean and stability of the tree	The tree is leaning away from the proposed new building and carpark. The tree is stable.
f	Soil characteristics	The soil is sandy and the water table is high. The trees roots are not expected to grow very deeply in this location due to the high water table.
g	The presence of existing or past structures	As noted there is an existing gravel carpark near the tree.
h	Design factors	The units and carpark have been designed to give as much clearance to the tree as is practicable.

AS 4970 Section 3.3.4 Encroachment considerations		Considerations for this tree
a	Location and distribution of roots to be determined through non destructive investigation methods.	No investigation of root locations has been undertaken. As the existing driveway has been in place for several years it is unlikely that there are structural roots growing under the gravelled area. There are likely to be some roots growing in the additional area affected by the proposed development.
b	The potential loss of root mass resulting from the encroachment.	The theoretical encroachment into the TPZ is 17% and SRZ of this tree is 11%. However most of this area is already covered by a gravel carpark. The actual additional encroachment is small. The work proposed will be on top of the existing soil grade and will not result in the destruction of significant amounts of existing roots.
c	Tree species and tolerance to root disturbance.	She Oak trees are a moderately hardy species and tolerant of root disturbance and root loss.

d	Age, vigour and size of the tree	The tree is a mature aged tree. The tree is moderately vigorous. It is a medium sized tree.
e	Lean and stability of the tree	The tree is leaning away from the proposed new building and carpark. The tree is stable.
f	Soil characteristics	The soil is sandy and the water table is high. The trees roots are not expected to grow very deeply in this location due to the high water table.
g	The presence of existing or past structures	As noted there is an existing gravel carpark near the tree.
h	Design factors	The units and carpark have been designed to give as much clearance to the tree as is practicable.

AS 4970 Section 3.3.4 Encroachment considerations		Considerations for this tree
a	Location and distribution of roots to be determined through non destructive investigation methods.	No investigation of root locations has been undertaken. As the existing driveway has been in place for several years it is unlikely that there are structural roots growing under the gravelled area. There are likely to be some roots growing in the additional area affected by the proposed development.
b	The potential loss of root mass resulting from the encroachment.	The theoretical encroachment into the TPZ is 16% and SRZ of this tree is 14%. However most of this area is already covered by a gravel carpark. The actual additional encroachment is small. The work proposed will be on top of the existing soil grade and will not result in the destruction of significant amounts of existing roots.
c	Tree species and tolerance to root disturbance.	Tuckeroo trees are a very hardy species and tolerant of root disturbance and root loss.

d	Age, vigour and size of the tree	The tree is a mature aged tree. The tree is moderately vigorous. It is small for its age due to the suppressing effect of the She Oak trees.
e	Lean and stability of the tree	The tree is leaning away from the proposed new building and carpark. The tree is stable.
f	Soil characteristics	The soil is sandy and the water table is high. The trees roots are not expected to grow very deeply in this location due to the high water table.
g	The presence of existing or past structures	As noted there is an existing gravel carpark near the tree.
h	Design factors	The units and carpark have been designed to give as much clearance to the tree as is practicable.

AS 4970 Section 3.3.4 Encroachment considerations		Considerations for this tree
a	Location and distribution of roots to be determined through non destructive investigation methods.	No investigation of root locations has been undertaken. As the existing driveway has been in place for several years it is unlikely that there are structural roots growing under the gravelled area. There are likely to be some roots growing in the additional area affected by the proposed development.
b	The potential loss of root mass resulting from the encroachment.	The theoretical encroachment into the TPZ is 17% and SRZ of this tree is 8%. However most of this area is already covered by a gravel carpark. The actual additional encroachment is small. The work proposed will be on top of the existing soil grade and will not result in the destruction of significant amounts of existing roots.
c	Tree species and tolerance to root disturbance.	She Oak trees are a moderately hardy species and tolerant of root disturbance and root loss.

d	Age, vigour and size of the tree	The tree is a mature aged tree. The tree is moderately vigorous. It is a medium sized tree with an upright form
e	Lean and stability of the tree	The tree has an upright form. The tree is stable.
f	Soil characteristics	The soil is sandy and the water table is high. The trees roots are not expected to grow very deeply in this location due to the high water table.
g	The presence of existing or past structures	As noted there is an existing gravel carpark near the tree.
h	Design factors	The units and carpark have been designed to give as much clearance to the tree as is practicable.
