## GEOTECHNICAL SITE INVESTIGATION

28 Kingsley Street, Byron Bay, NSW 2481.

H24-4249.

9<sup>th</sup> April 2024

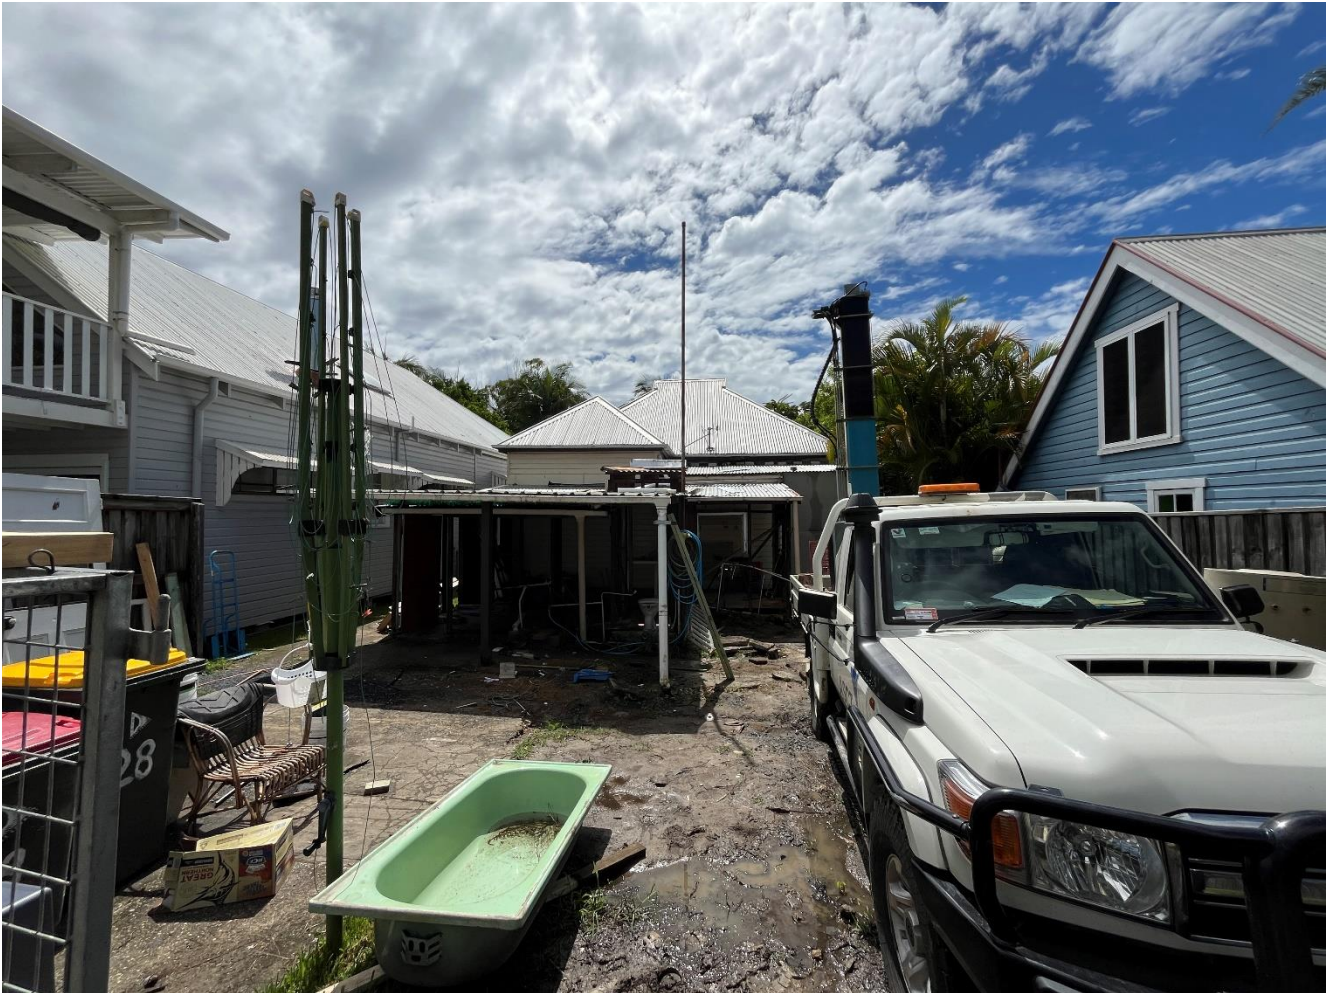
View of the site facing a northerly direction.

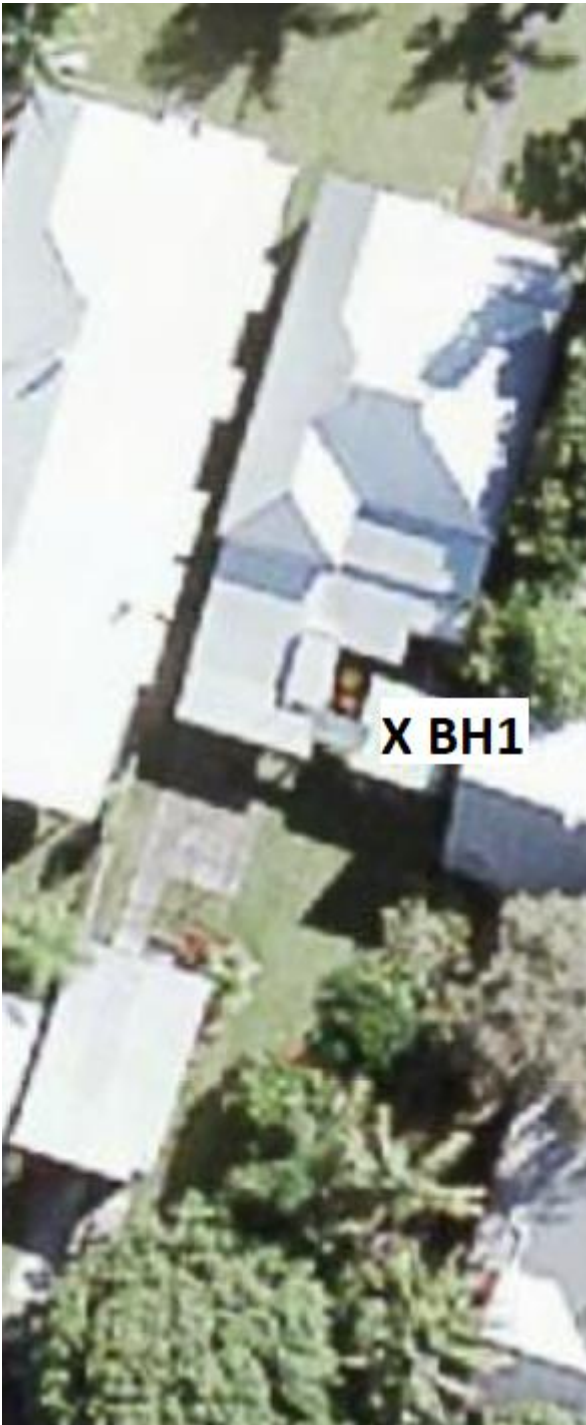
**Aerial view of the site, with ASCT test positions.**
