GEOTECHNICAL SITE INVESTIGATION

56 Ann Street, Mullumbimby, NSW
2482.

ASCT Reference
[H22-3293.](#)

Re: Proposed New Dwelling at 56 Ann Street, Mullumbimby, NSW 2482.

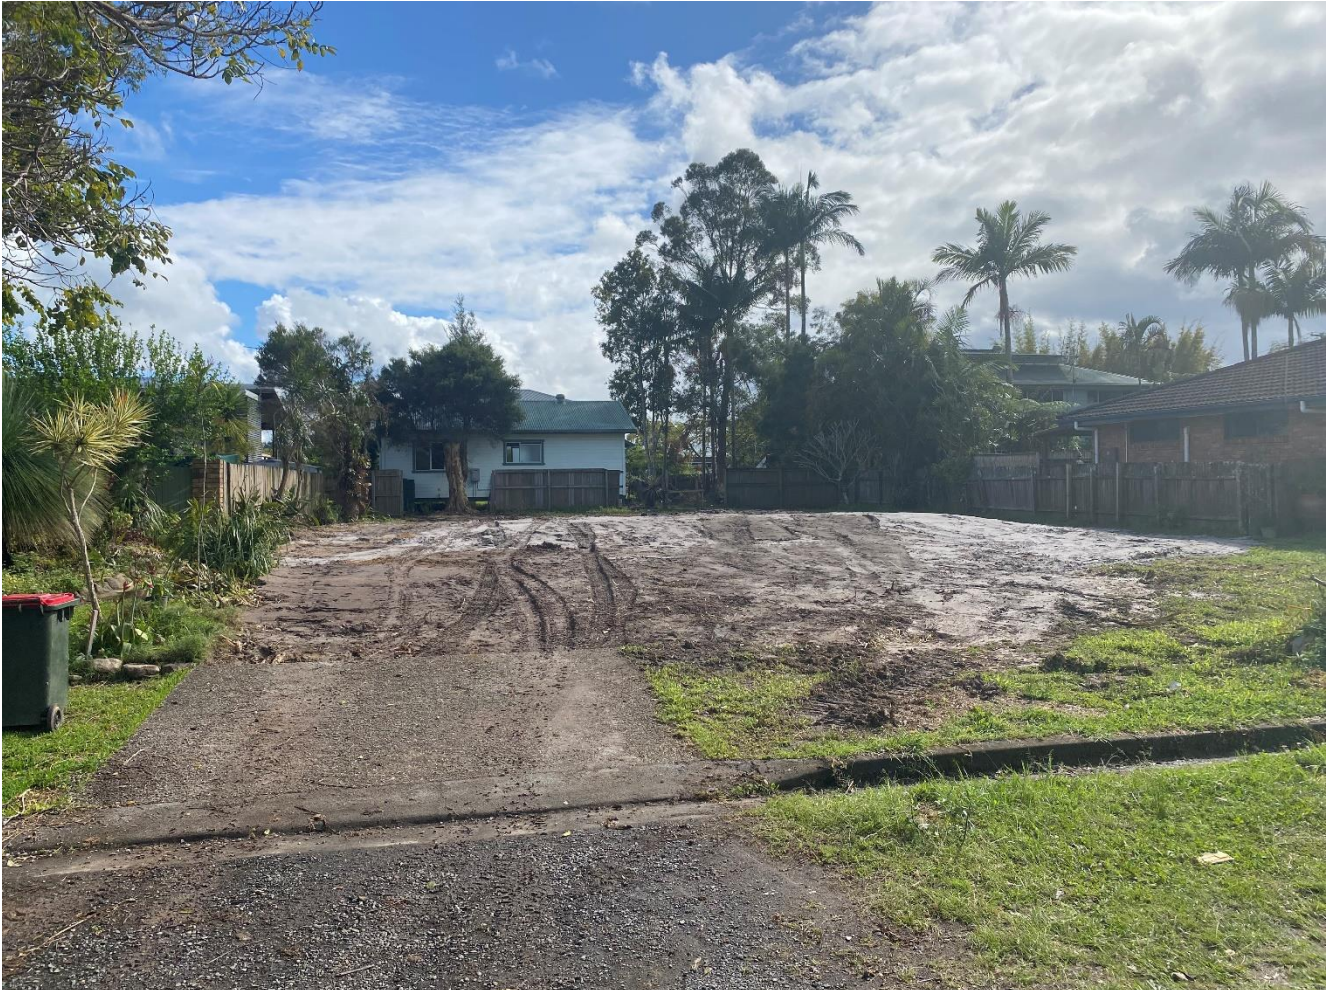
Some small tree and vegetation surrounding the sites perimeter may affect the sites normal moisture conditions.

No significant water sources were observed.

View of the site facing a northerly direction.

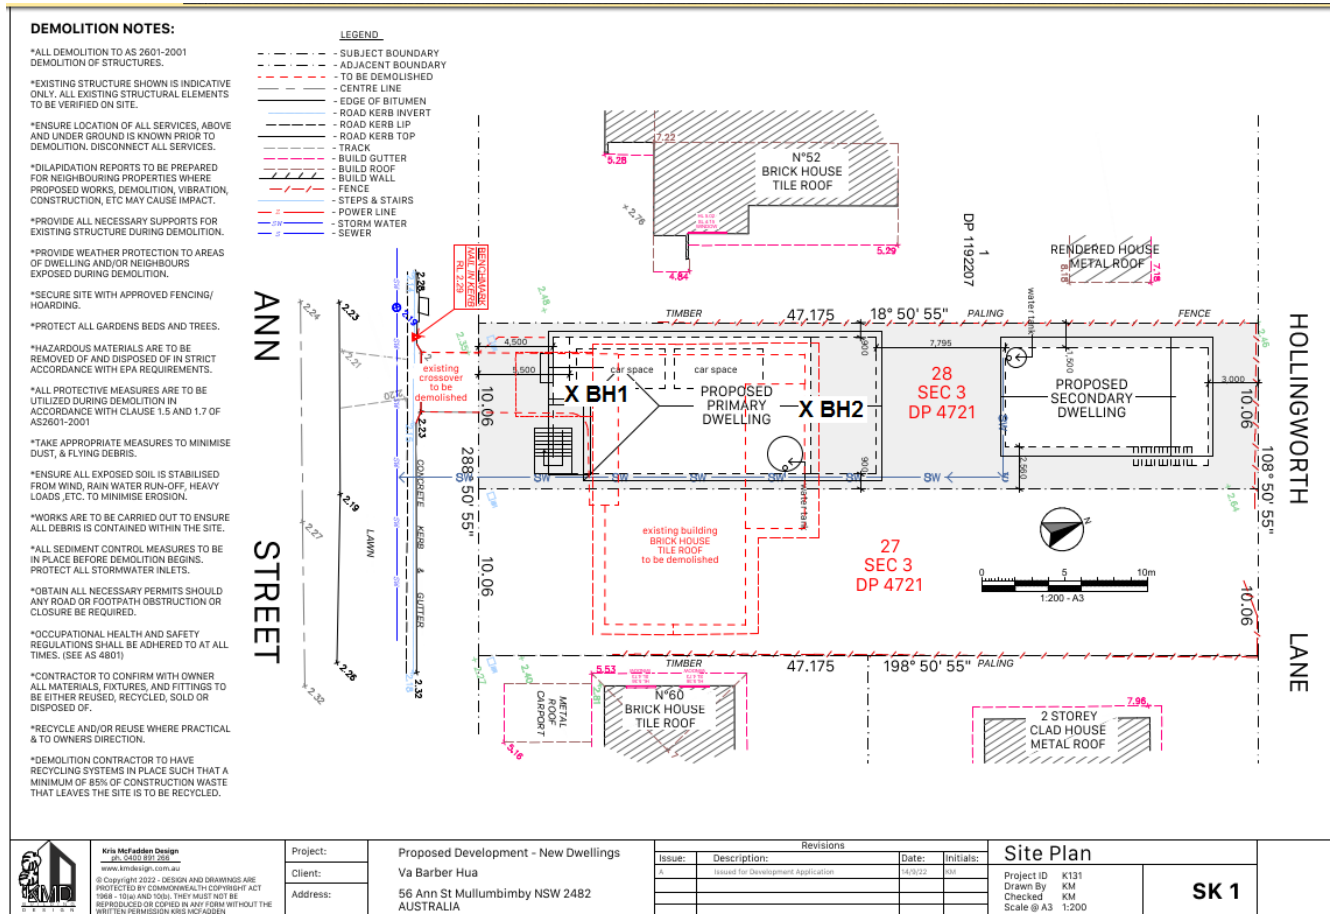
Plan of the site, with ASCT test positions.
