ACID SULFATE SOIL REPORT: Proposed Residential Development

29 Shirley Street and 2-4 Milton Street

PG-7463

**ACID SULFATE SOIL INVESTIGATION – PROPOSED RESIDENTIAL DEVELOPMENT
29 SHIRLEY STREET AND 2-4 MILTON STREET, BYRON BAY**

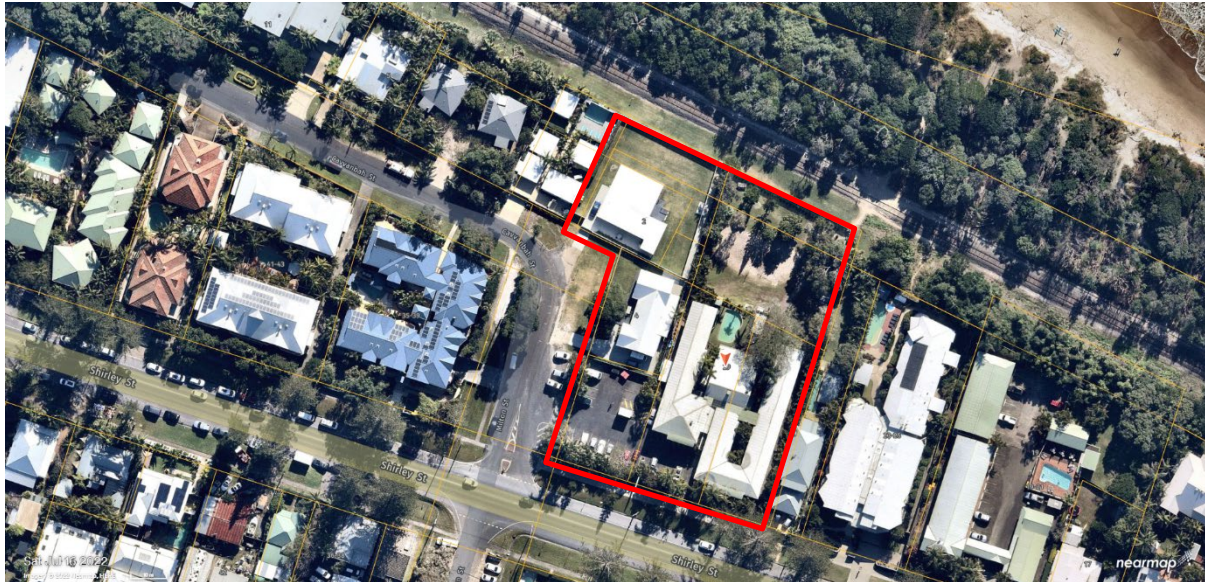
AERIAL IMAGE

At the time of the investigation, the site was occupied by an existing backpackers accommodation building, with associated car parking, swimming pool, courtyard, gardens and volleyball courts.

Vegetation comprised short grass cover, and medium to large sized trees and shrubs.

The site was generally level and drainage was considered fair to poor but improved by the local stormwater network around the existing structures.

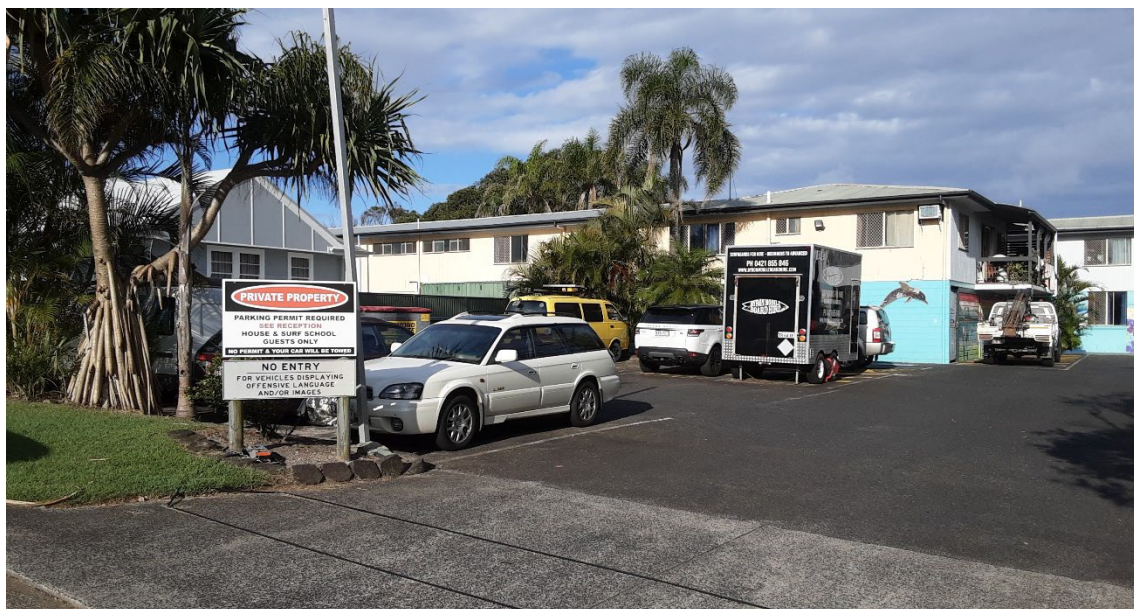
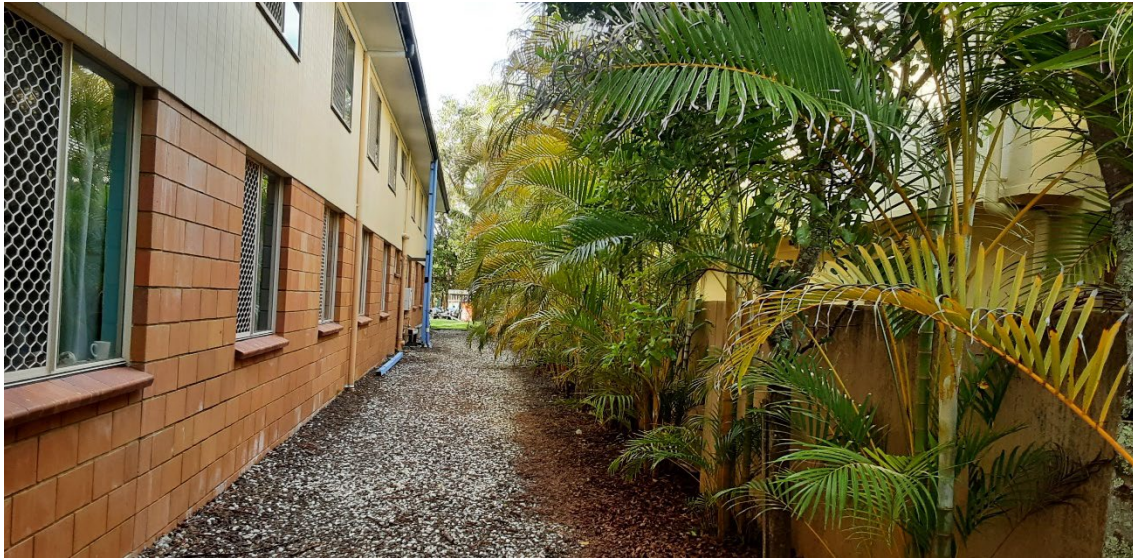
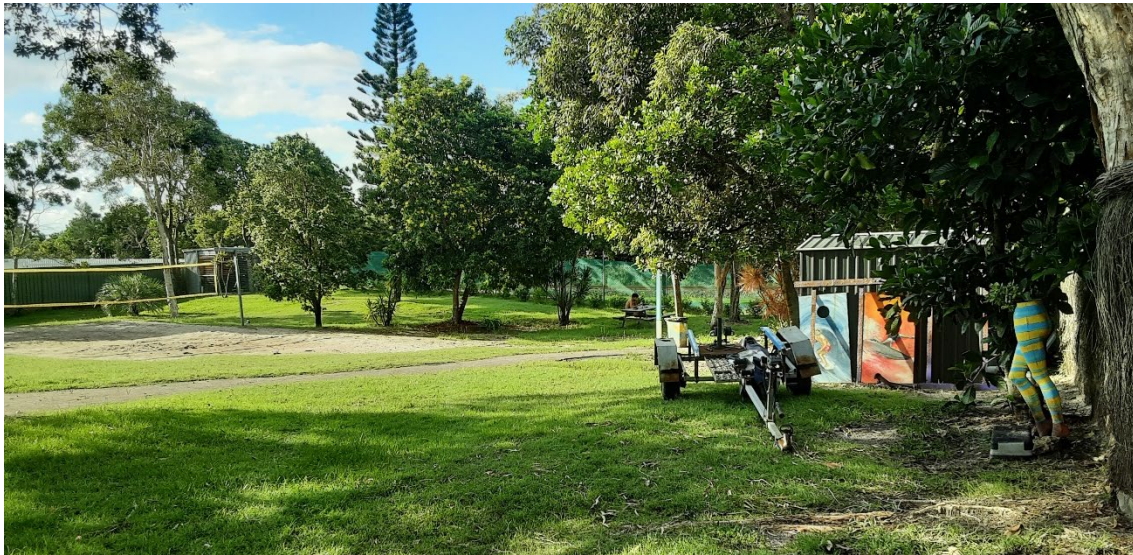
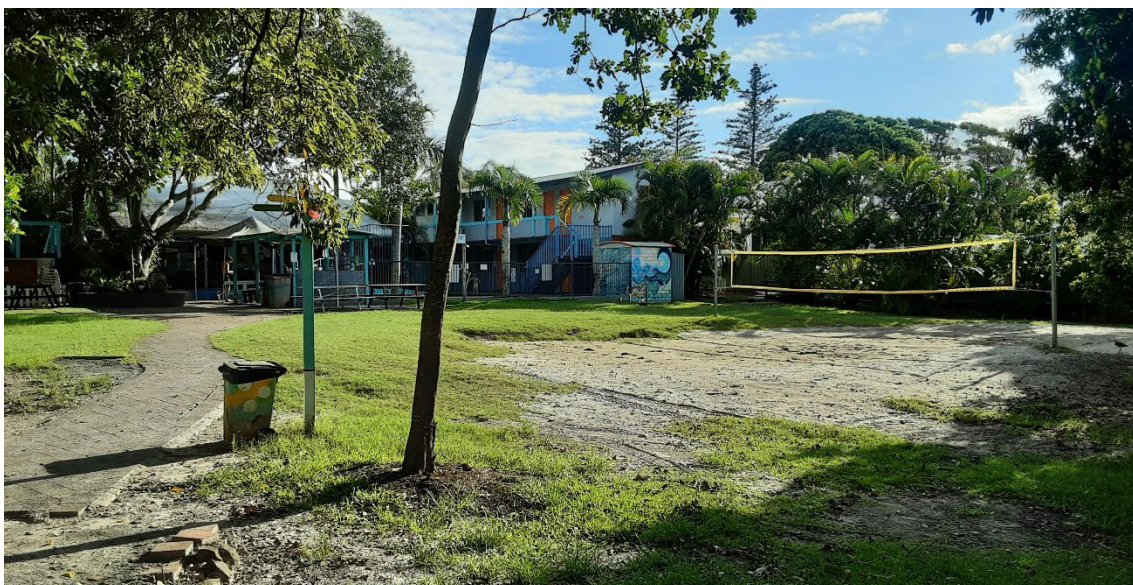
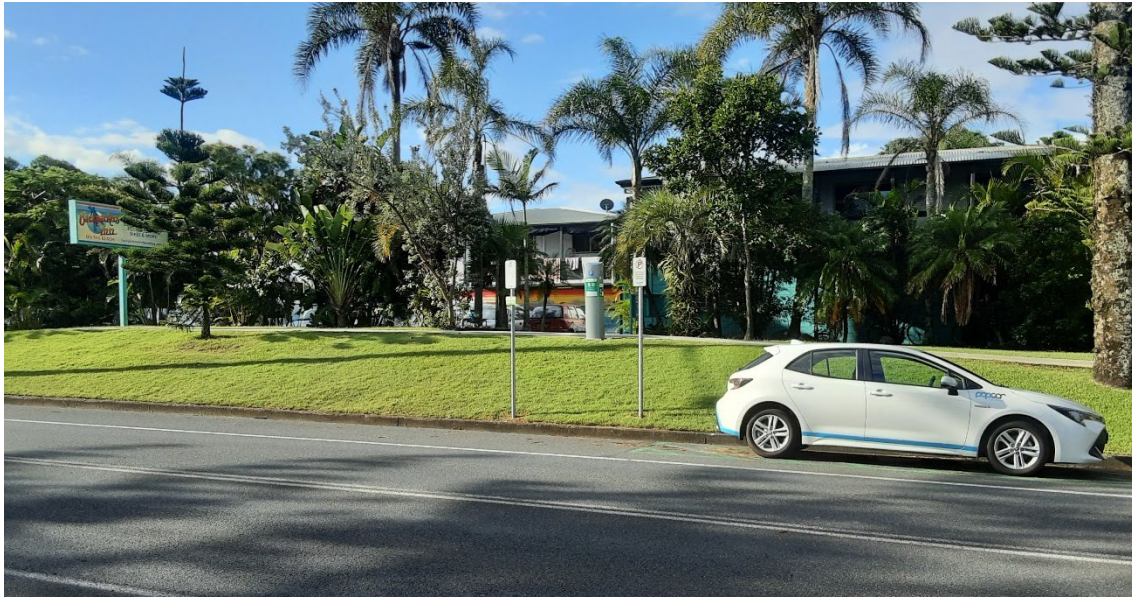
SITE PHOTOGRAPHS

Refer following aerial and site photographs for typical site conditions.

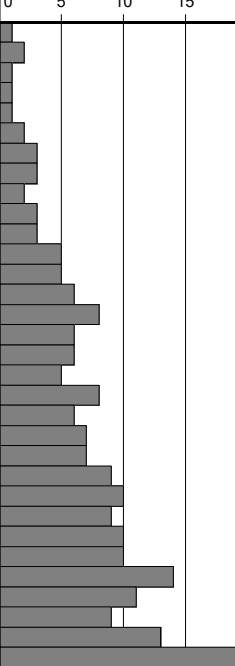
SP	FILL SAND (SP) Very loose, fine grained, light grey, trace of fine to medium sized gravel, moist.

0.30		SP	NATURAL SAND (SP) Very loose to loose, fine grained, dark grey, moist.							
			ASS 0.50-1.00 m			0.60			SP		SAND (SP) Very loose, fine grained, dark grey, moist.					
			D 0.60-1.00 m					SP	SAND (SP) Loose to medium dense, fine grained, light grey, moist.							
			ASS 1.00-1.50 m		1	1.10			SP		SAND (SP) Medium dense, fine grained, light grey, moist.					
			ASS 1.50-2.00 m													
			ASS 2.00-2.50 m		2	2.10			SP		SAND (SP) Medium dense, fine to medium grained, light grey brown, wet.					
			ASS 2.50-3.00 m													
			D 2.60-3.00 m													
						3		3.20			SP	SAND (SP) Dense, fine to medium grained, brown, wet.

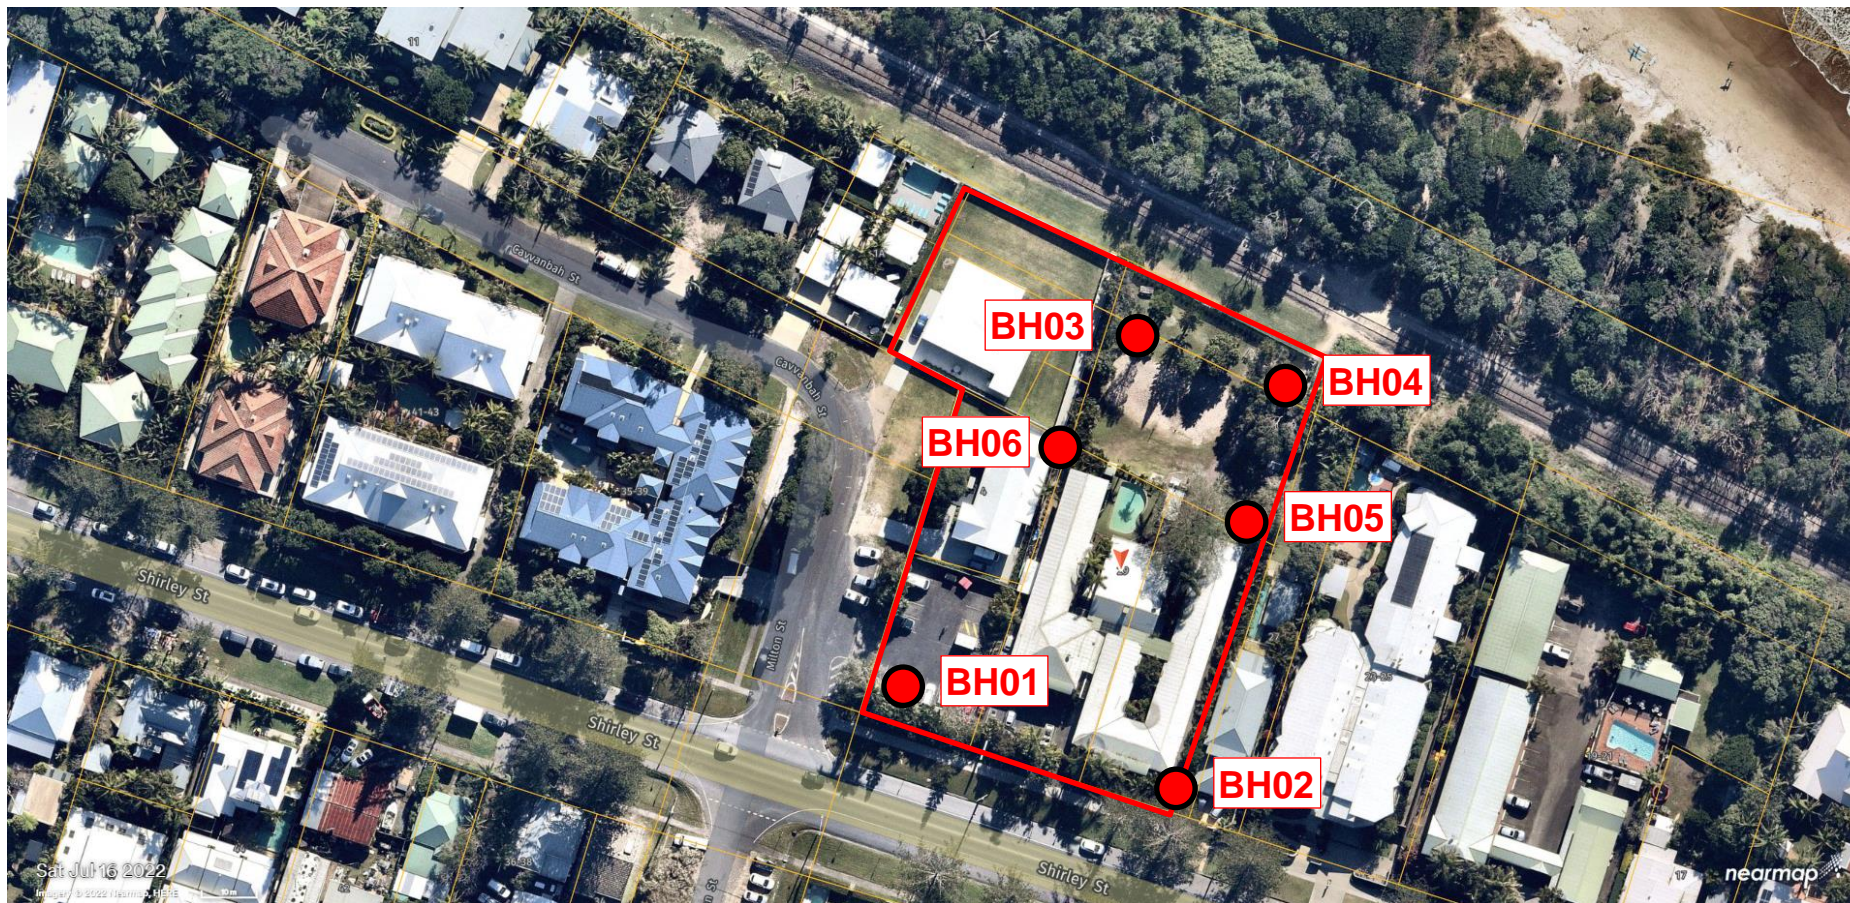
Drawn AB	Project:	Proposed Residential Development	Drawing No. PG-7463-02	A4
Date Jul 2022	Location:	29 Shirley Street and 2-4 Milton Street, Byron Bay		
Checked	Client:	One Project MGMT Group

Borehole records, Dynamic Cone Penetrometer test results and a site plan showing the test locations are appended to the report.
