## **REPORT ON GEOTECHNICAL SITE INVESTIGATION**

**Proposed Dual Occupancy**

**Lot 4 DP 244699,  
23 Marine Parade, Byron Bay, NSW 2481**

**25 January 2025  
Project Ref: P599GI\_Rev1**

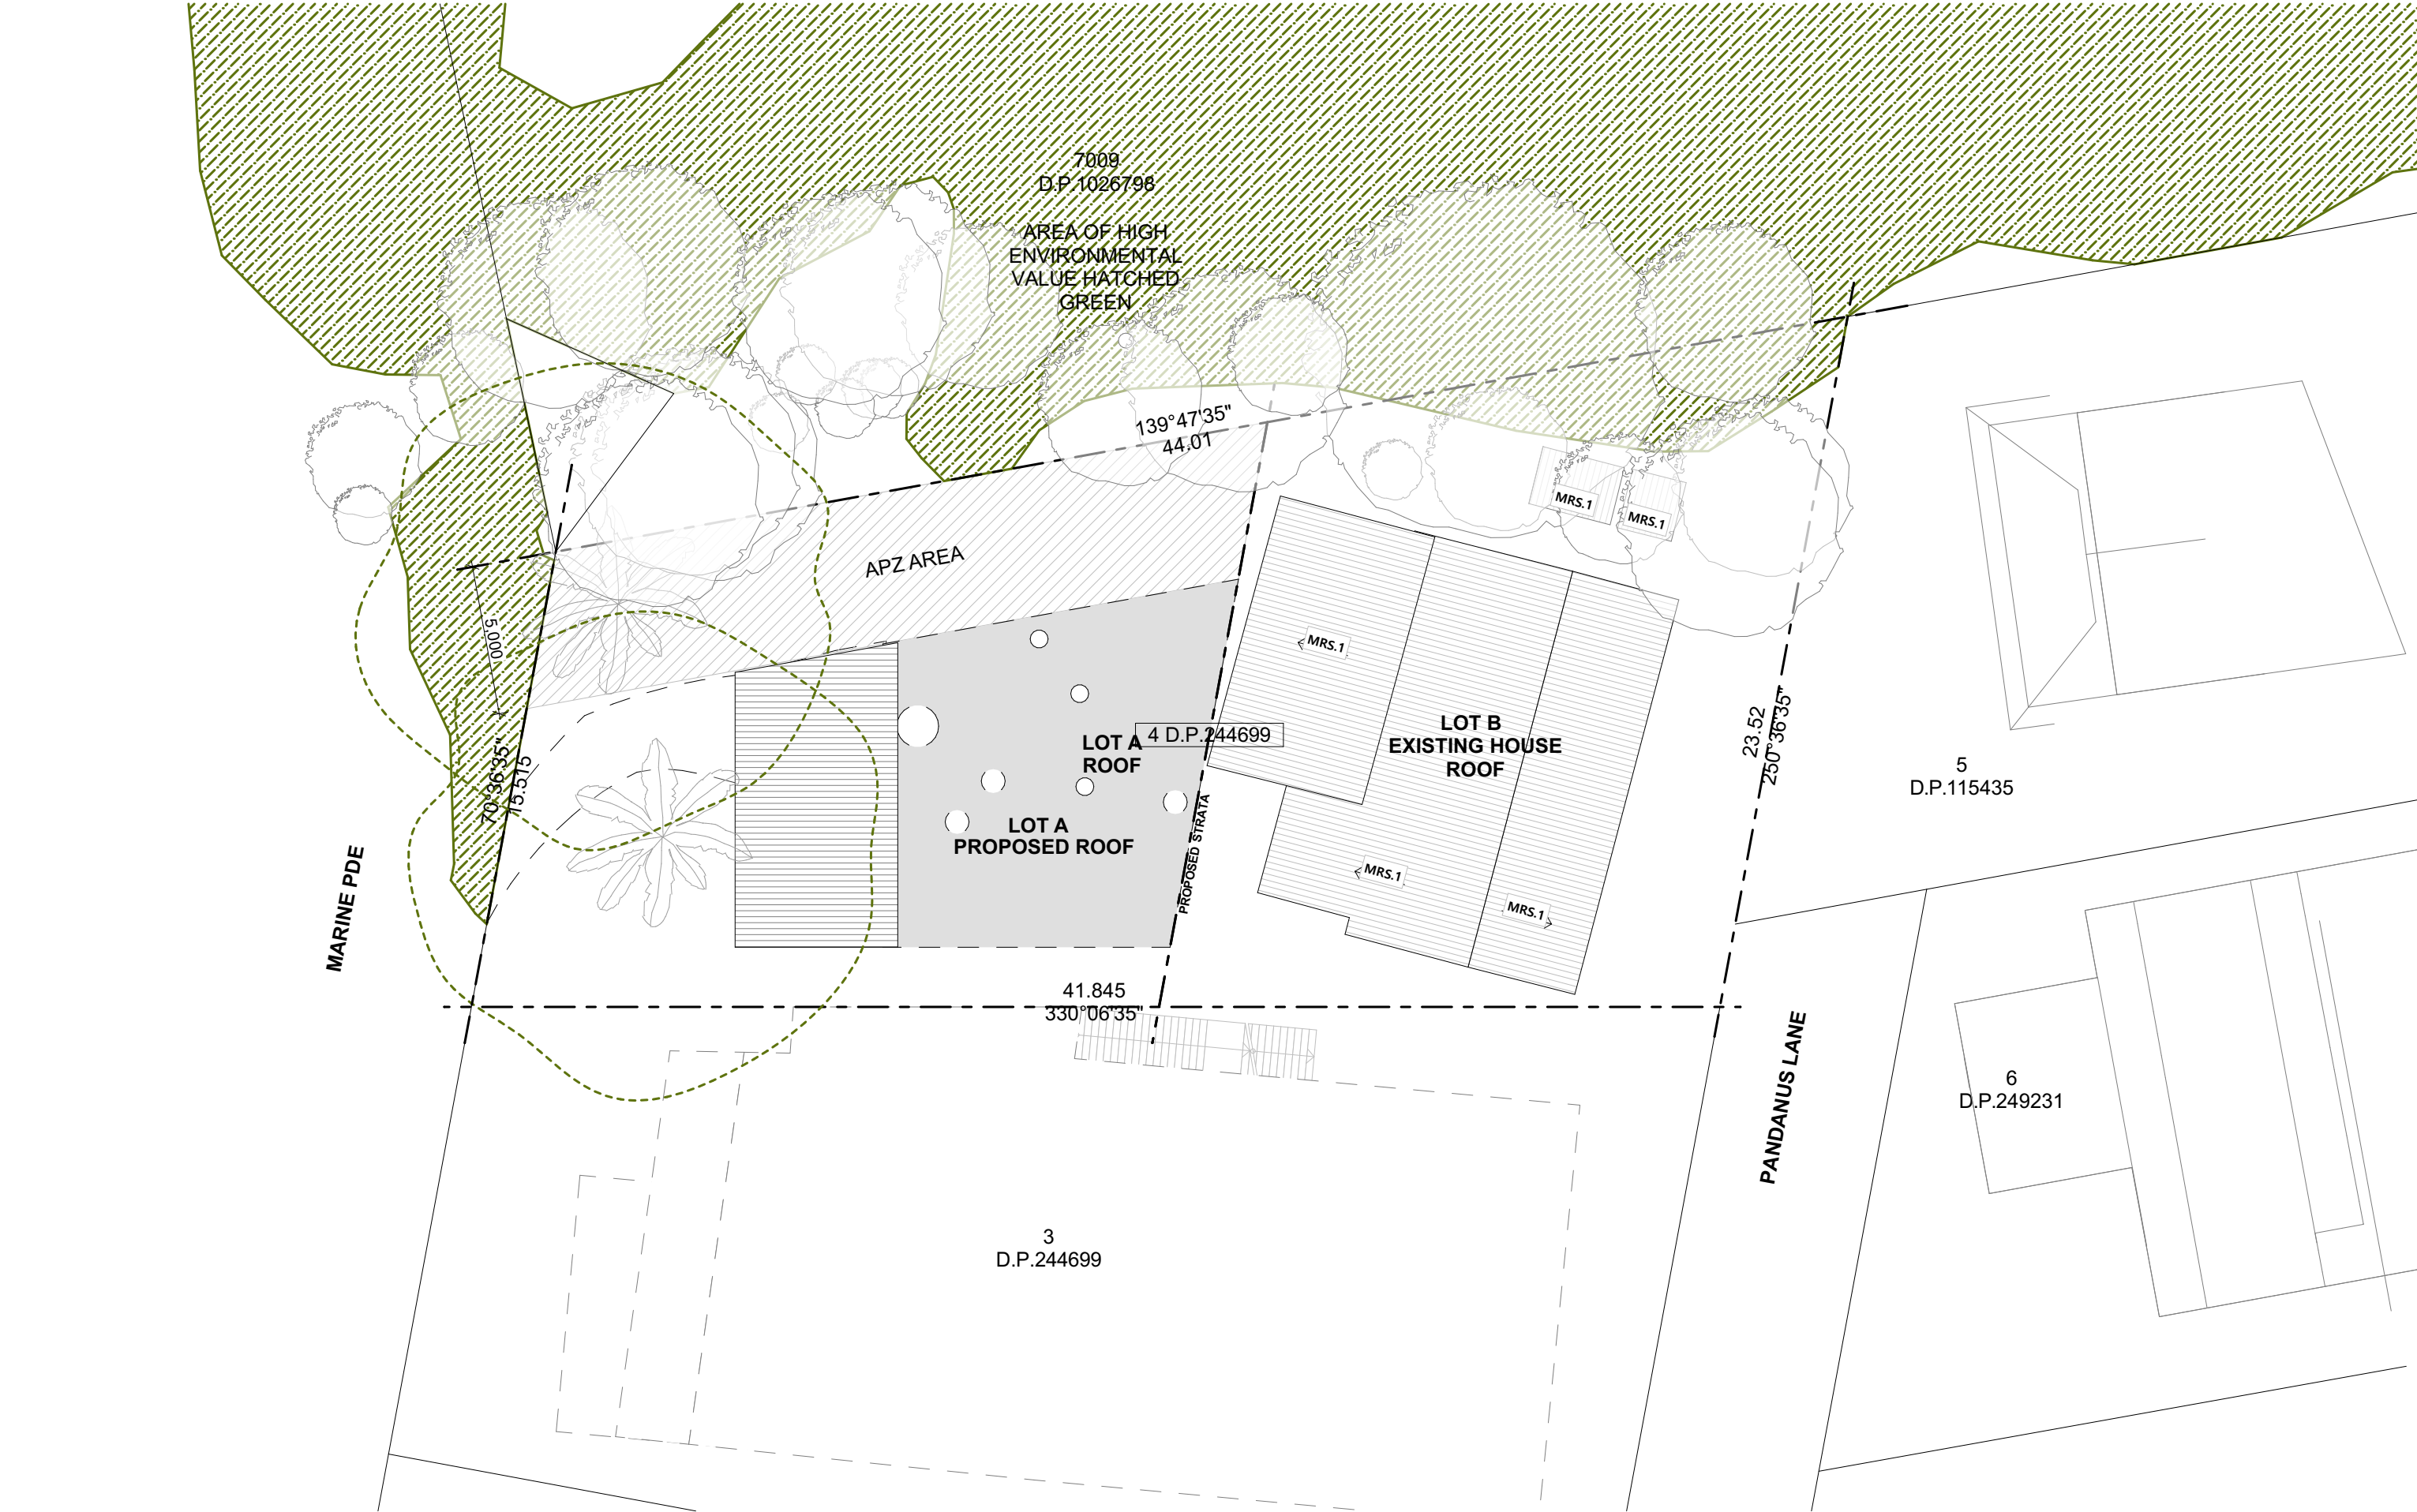
DRAWING NO.  
**A1.04**  
REVISION NO.  
**02 - WIP**  
7/08/2024

DRAWING TITLE :  
SITE  
**PROPOSED SITE PLAN**  
STATUS :  
**LANTERN HOUSE**

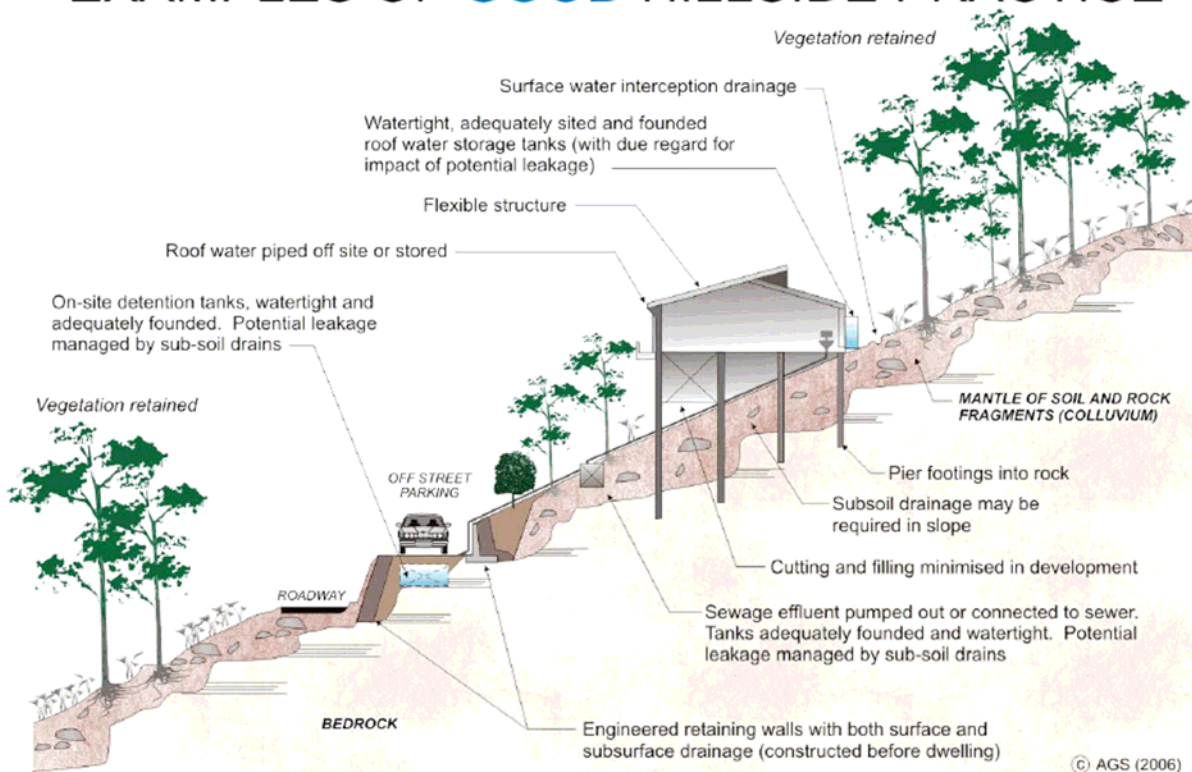
## EXAMPLES OF **GOOD** HILLSIDE PRACTICE

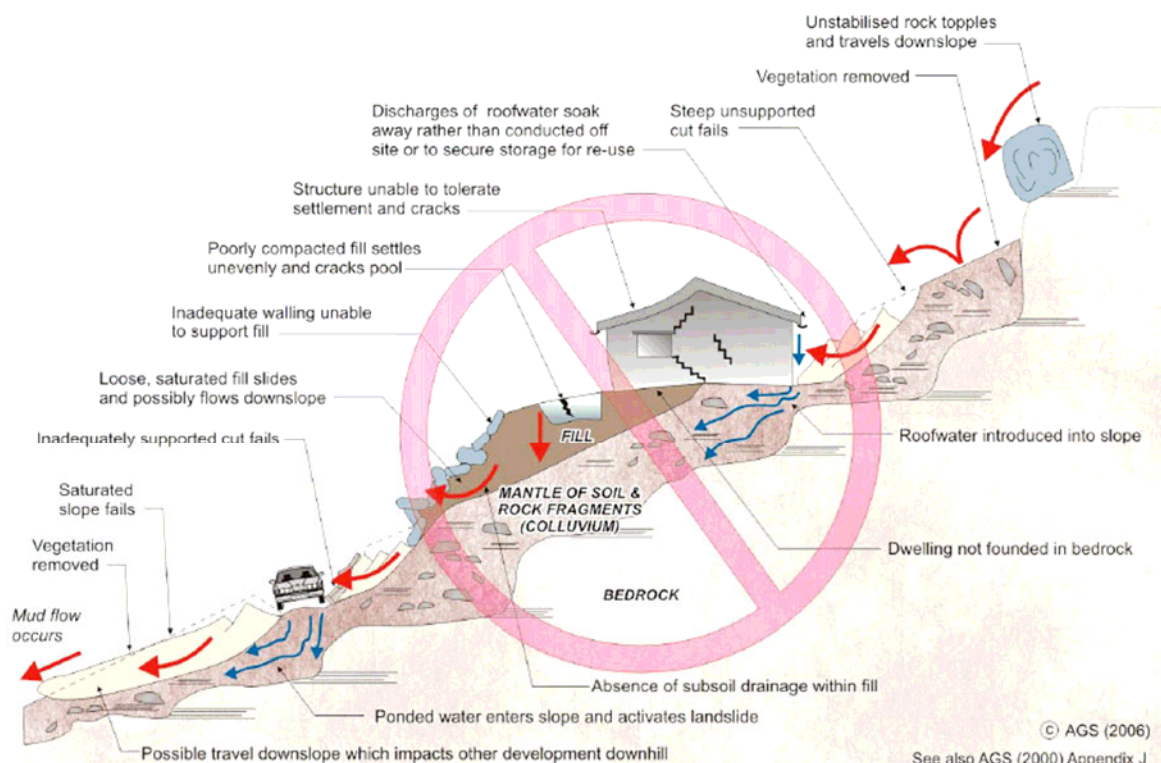
## EXAMPLES OF **POOR** HILLSIDE PRACTICE
