# **Preliminary Site Investigation SEPP 55 – Contamination Assessment**

## **Proposed Relocated Rural Dwelling**

163 The Saddle Road, Brunswick Heads  
Lot 1 DP 631177

**Date: June 2019**

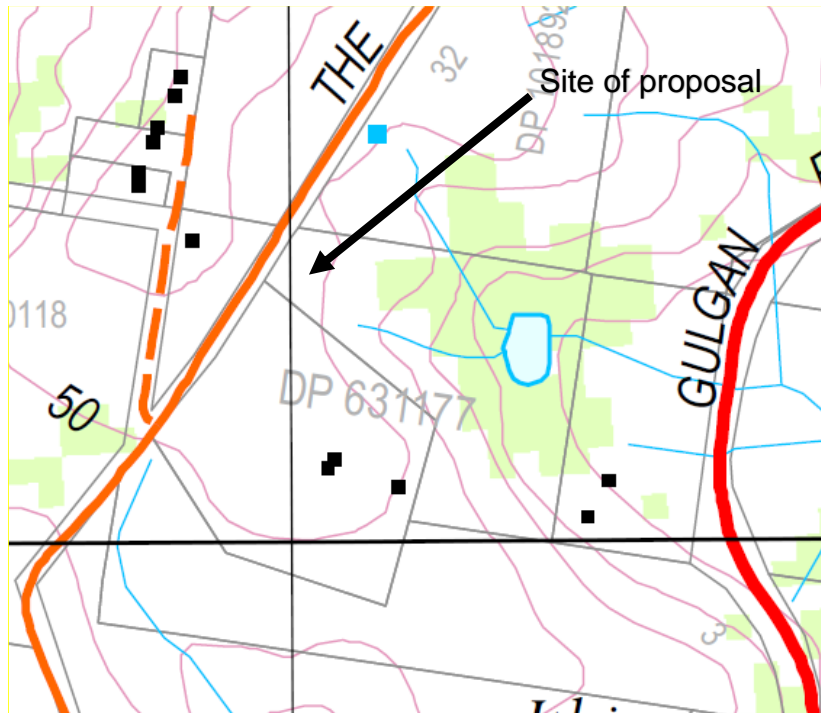
Figure 3: Site topography and drainage (NSW e-Topo. Maps)

The site of the proposed relocated dwelling is on an elevated portion of the subject property, in the western portion of the site, well above any drainage lines and a large dam. The site is located on the elevated Saddle Road escarpment.

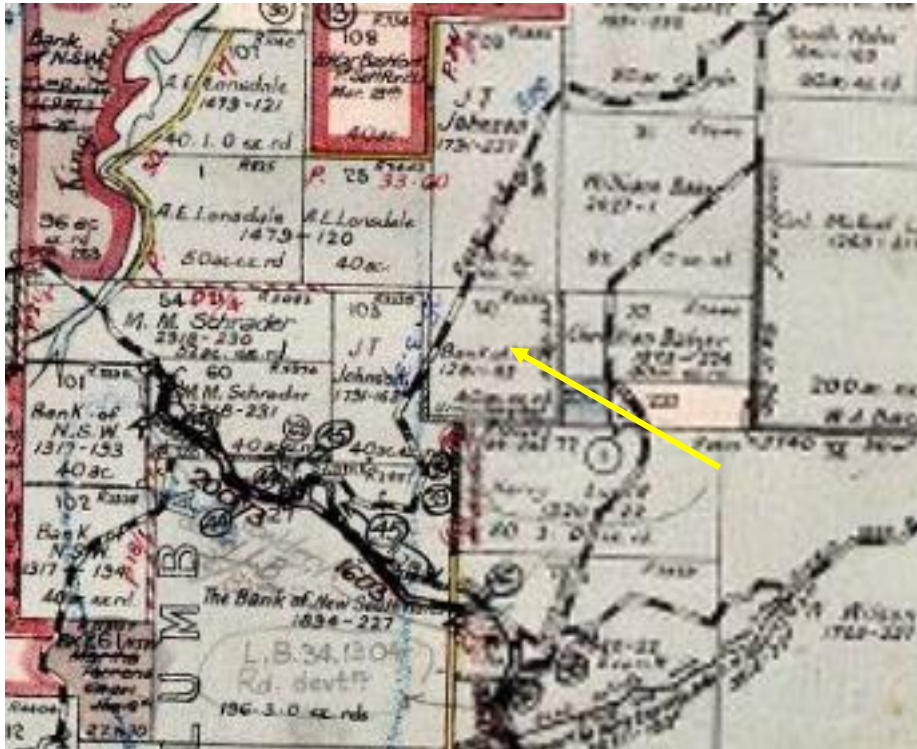
### Parish of Brunswick: Early 1900s (Edition 4)

The current property at can be identified as being part of Portion 30 Plan 2442.

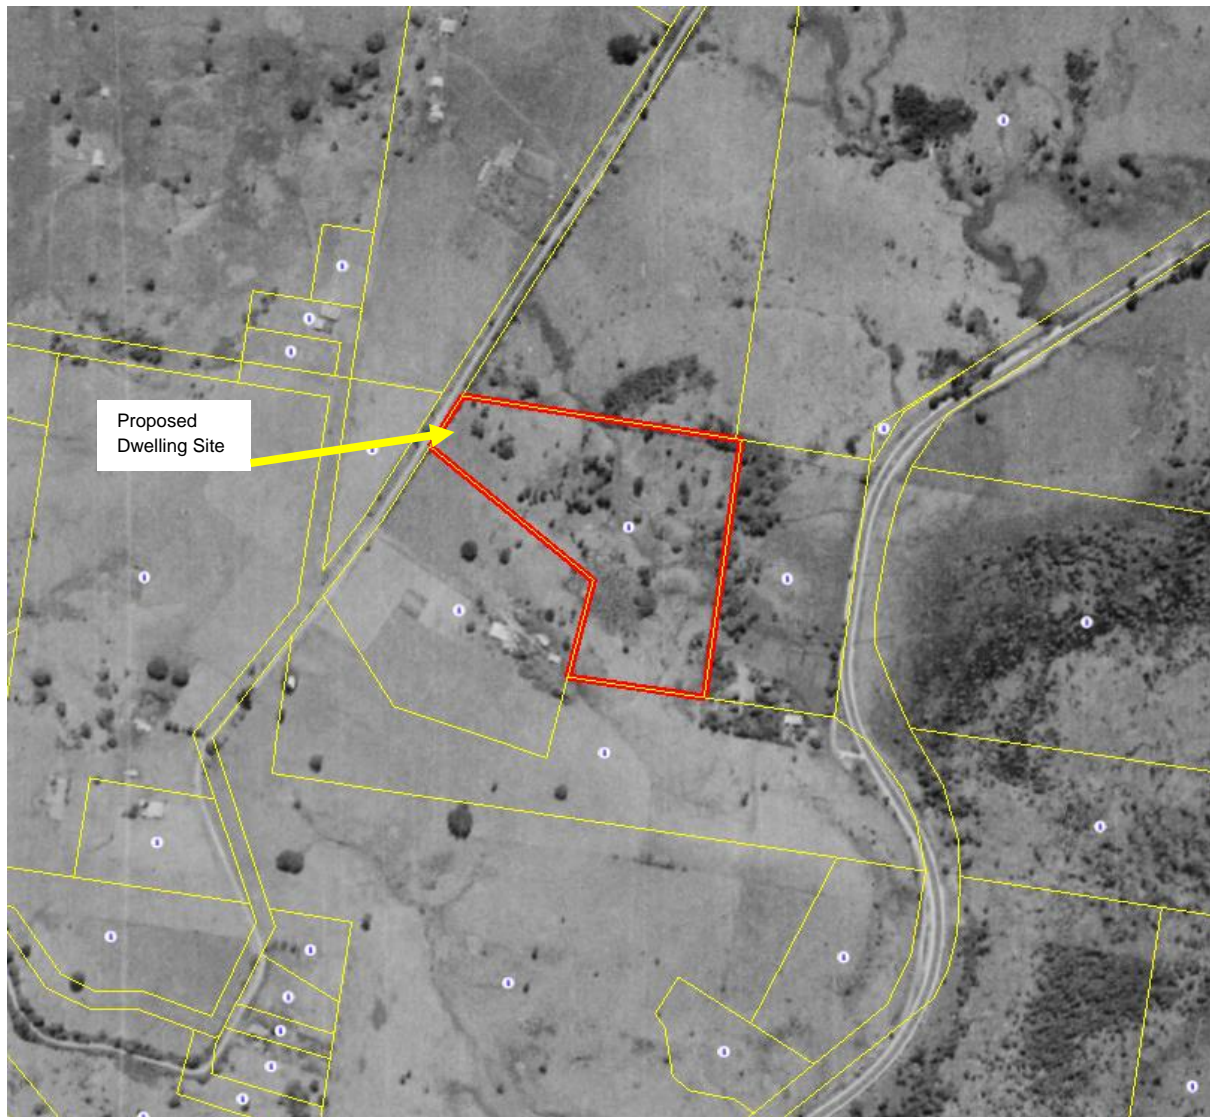
**1966 Aerial Photograph**

The photograph from 1966 show that the site of the proposed relocated dwelling did not contain any banana growing areas, and was likely used for grazing paddocks as part of the larger dairy farm holding. The main farm dwelling, dairy bails and piggery was located on the adjacent property to the south, being currently owned by a fellow family member.

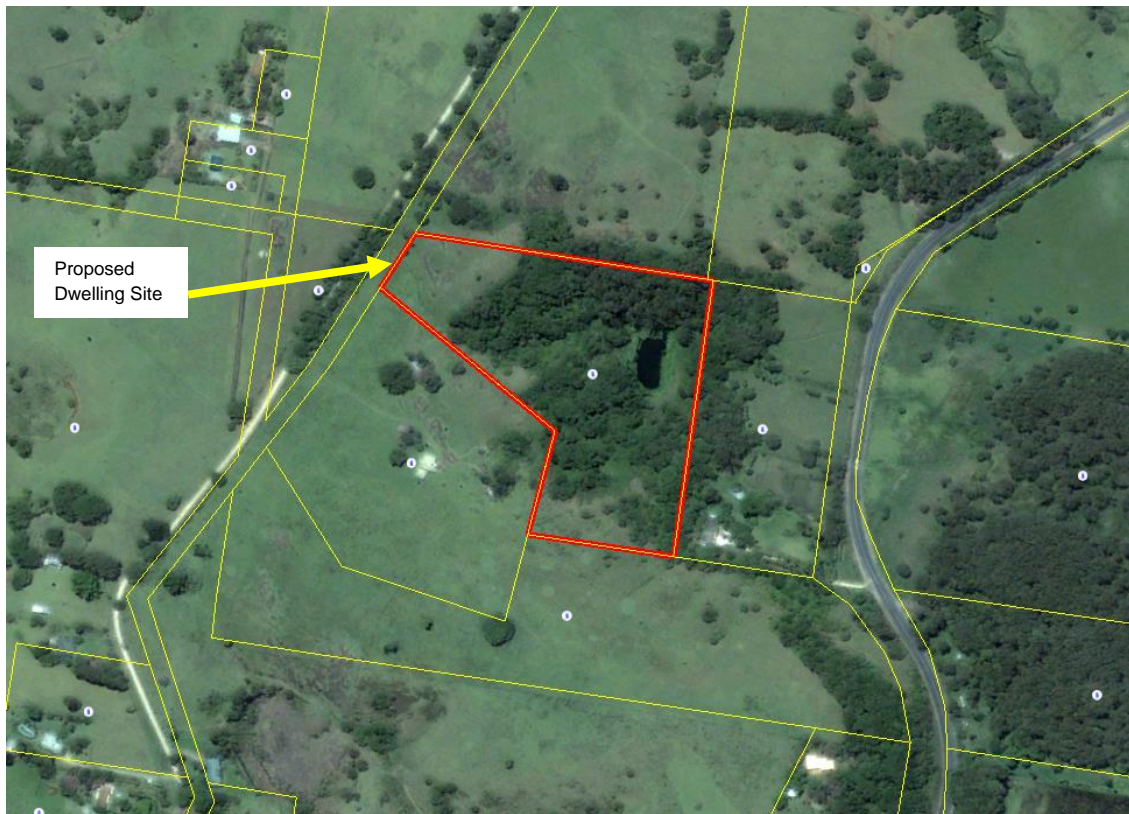
**2006 Aerial Photograph**

More recent aerial photographs from 2006 and 2019 show the approximate boundary of the current property, where the site of the proposed relocated dwelling remains as open paddock area.

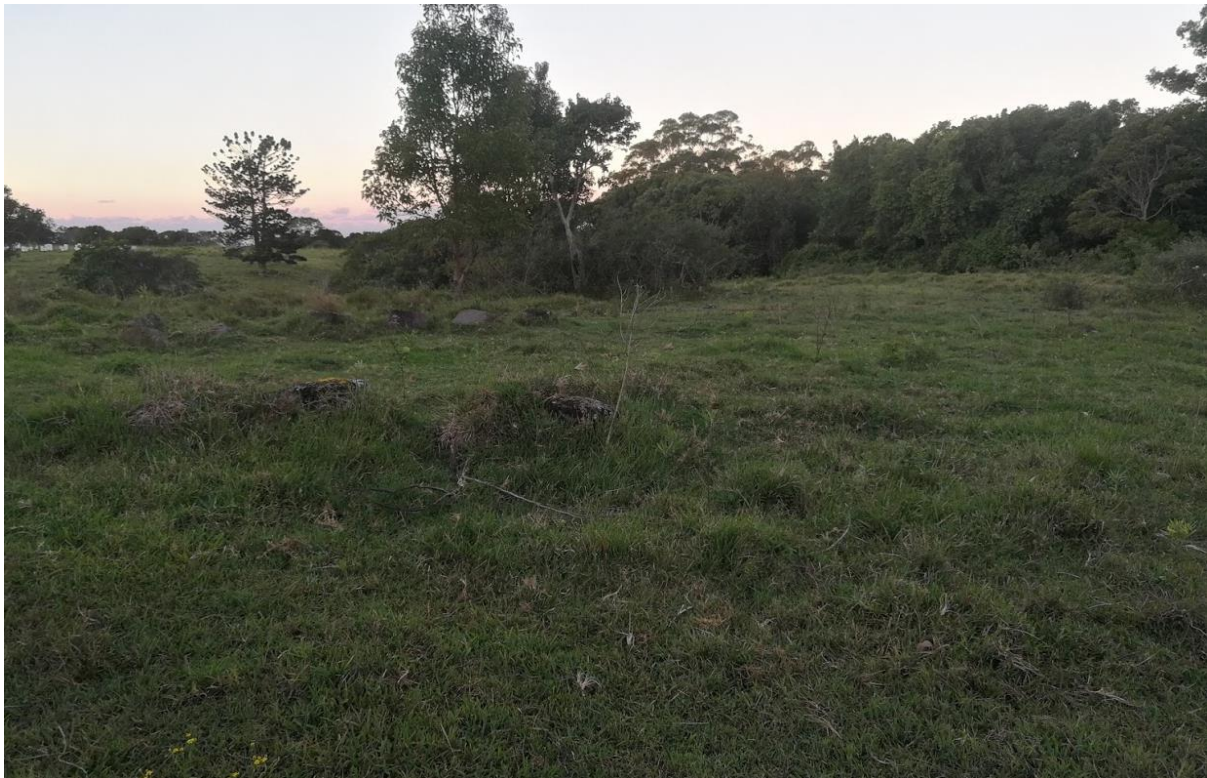
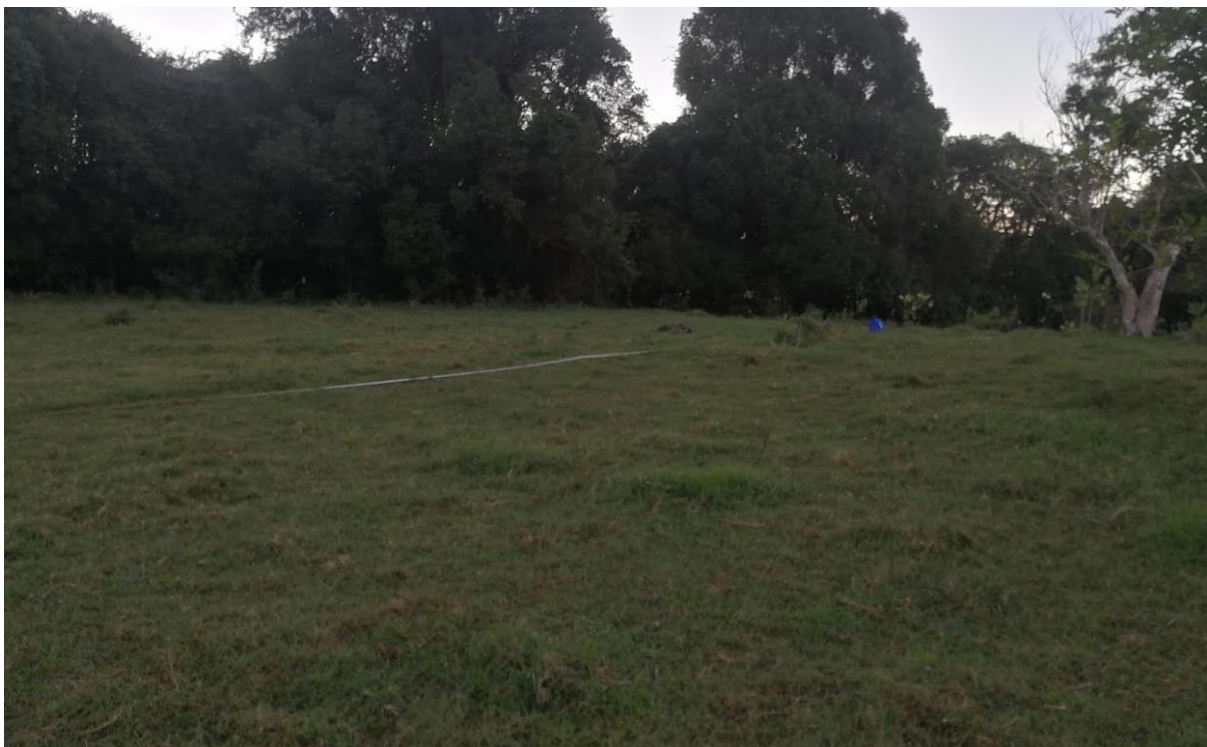
**Site of Proposed Dwelling**

The site of the proposed dwelling showed no signs of waste material or disturbance that may indicate potential soil contamination. The site demonstrated characteristics of a typical grazing paddock.

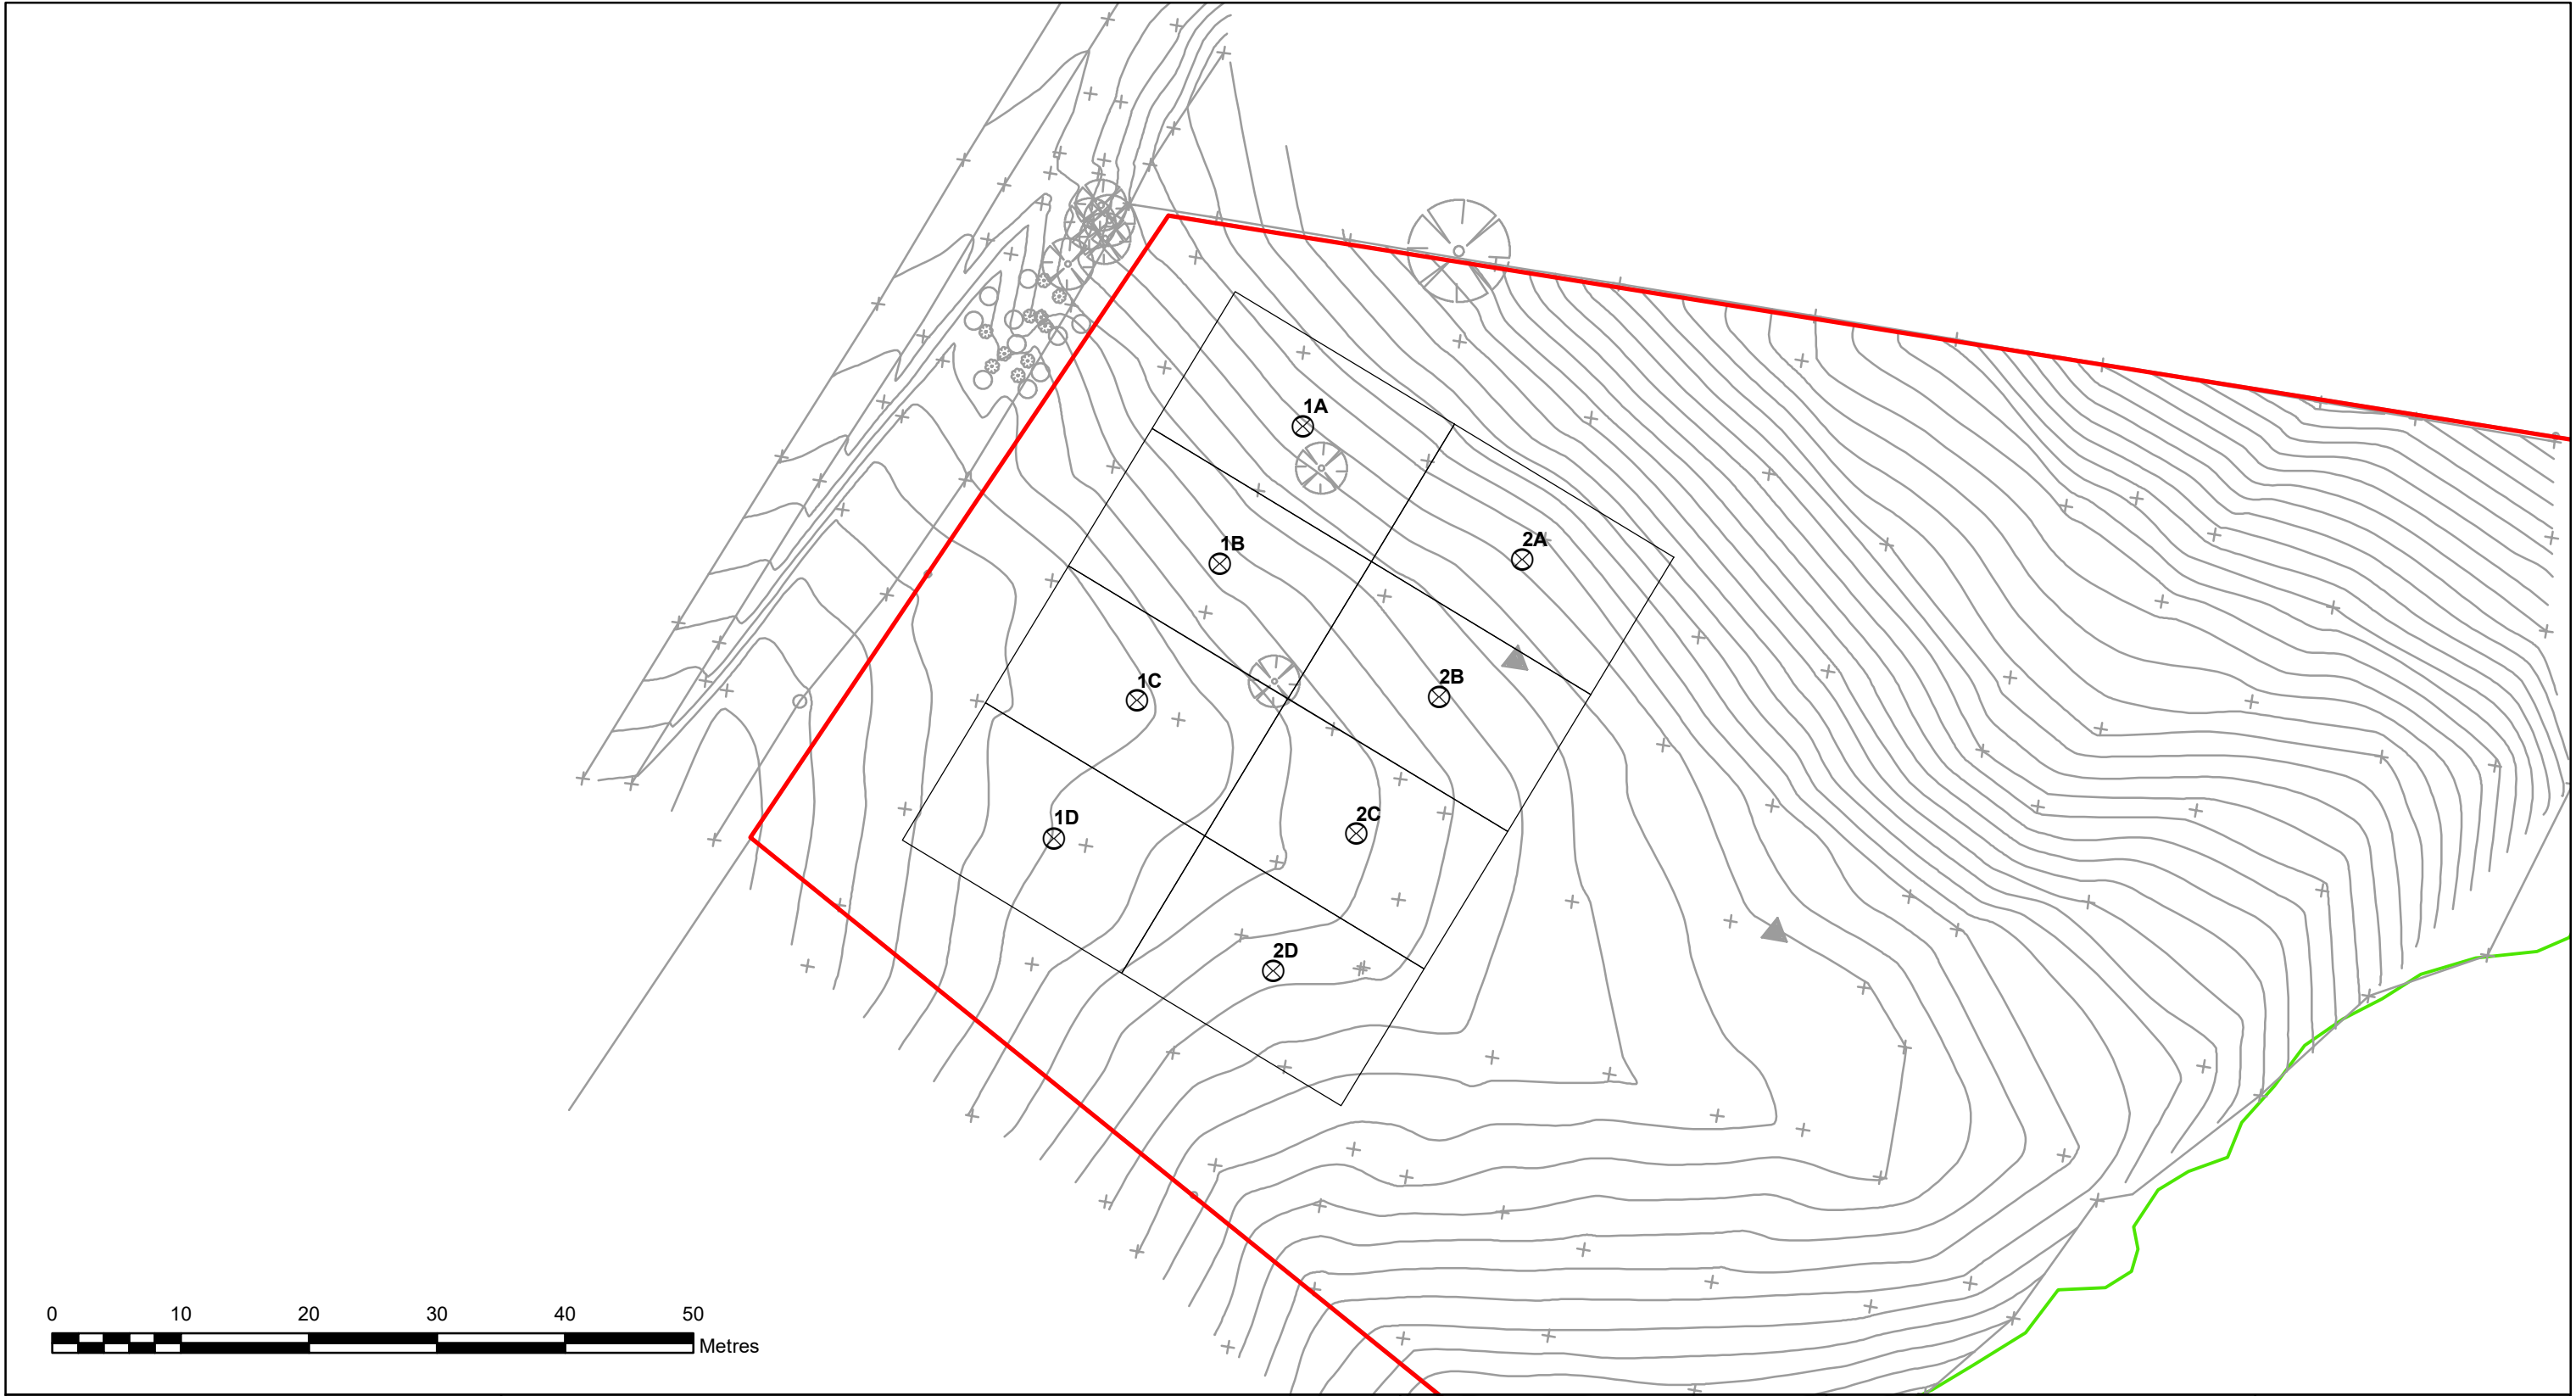
**Illustration:**  
**SEPP 55**  
**Sampling Plan**

A systematic soil sampling plan was developed to target possible contamination at the site of the proposed relocated dwelling, for a range of potential contaminants, as recommended by the NSW EPA (1995) guidelines.

A total of eight (8) individual soil samples were collected from the site of the proposal, resulting in two composite samples.

Sample Grid 40m x 50m (2000 sqm)
