Contamination and Hazardous Building Materials Validation

Date 16/12/2019

10 – 12 Shirley Street Byron Bay NSW 2481

re: Building validation following contamination and hazardous building material remediation

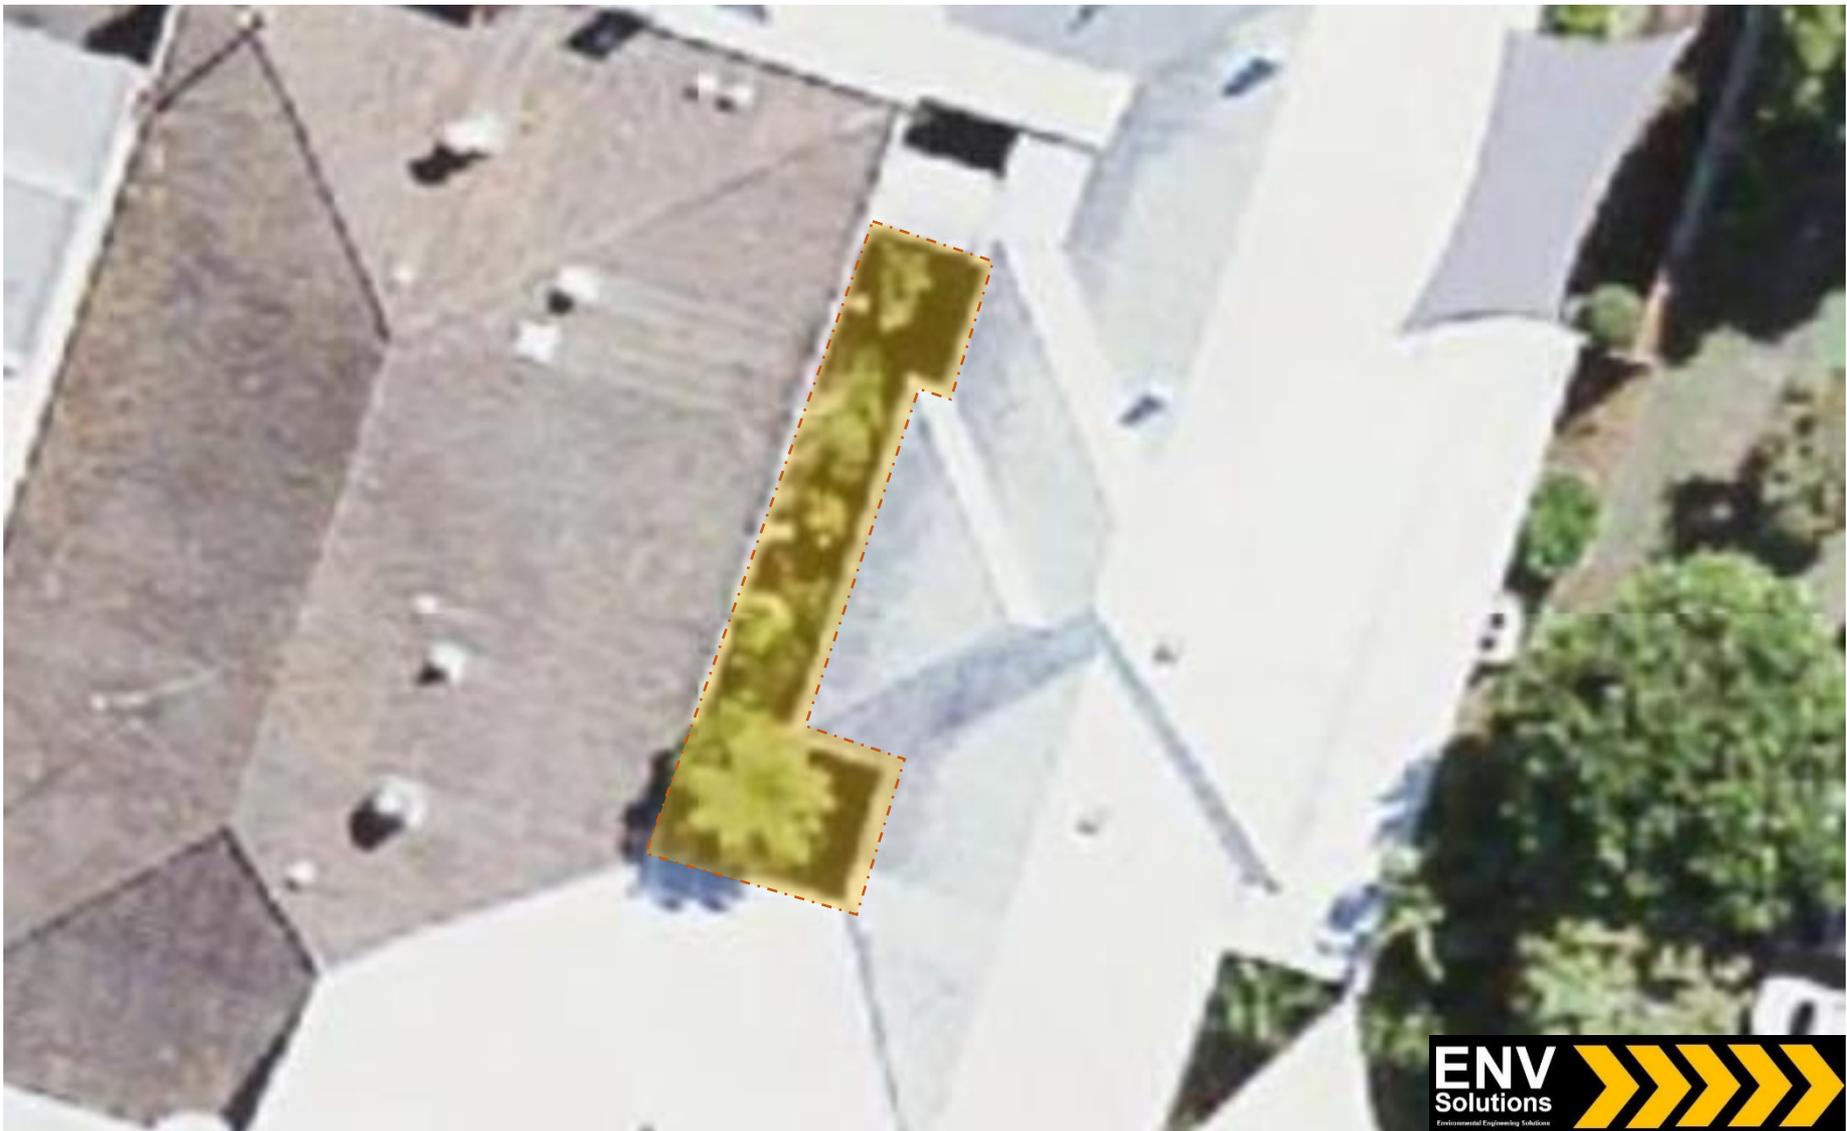
Remediation Area

A radiation survey was undertaken across the area utilising a 'Soeks 0.1M Prime' Gieger counter. An approximate 1 m x 1 m grid was set up over the area to ensure even coverage was achieved, reference to the sample locations can be found in Figure 3, **Attachment 4**. During the survey, radiation levels were measured from approximately 1.0 metre above the concrete slab. Radiation levels were observed between 0.11 and 0.48 $\mu\text{Sv/h}$, with the highest readings noted in the south-east of the area.

On this basis the observed background radiation levels are considered acceptable for commercial use.

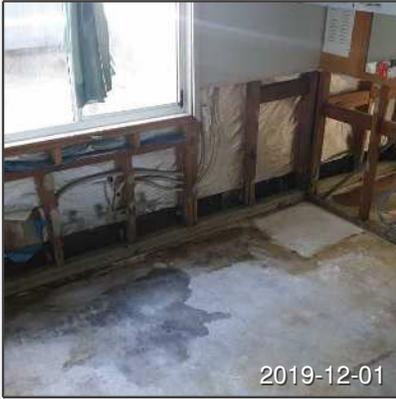
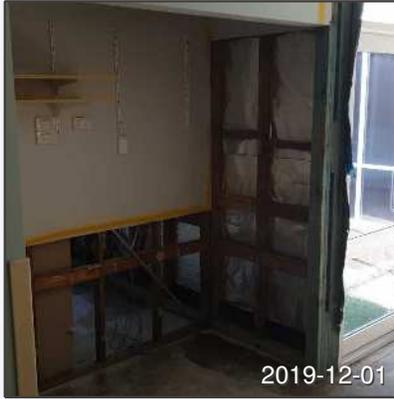
Office

The area around the atrium had previously presented a very high organic load as a result of significant fungal activity on the lower walls and support stud in the office. This area was completely de-lined to remove structure as required. An air sample was obtained near the major works. TSC load was comparable to outdoors and within 10% of the RANK as per the Worldwide Standard for Mould and Bacteria and the Worldwide Standards for Post Remedial Validation. TSC was 21053 with the same genera ordering (Cladosporium). Worthy of note is the high level of potential infiltration to Block 1 with no door seals and it being the most upwind part of the building.
