REPORT ON GEOTECHNICAL SITE INVESTIGATION

Three (3) Proposed Sheds

736 Federal Drive, Federal, NSW 2480

**22 July 2022
Project Ref: P363GI**

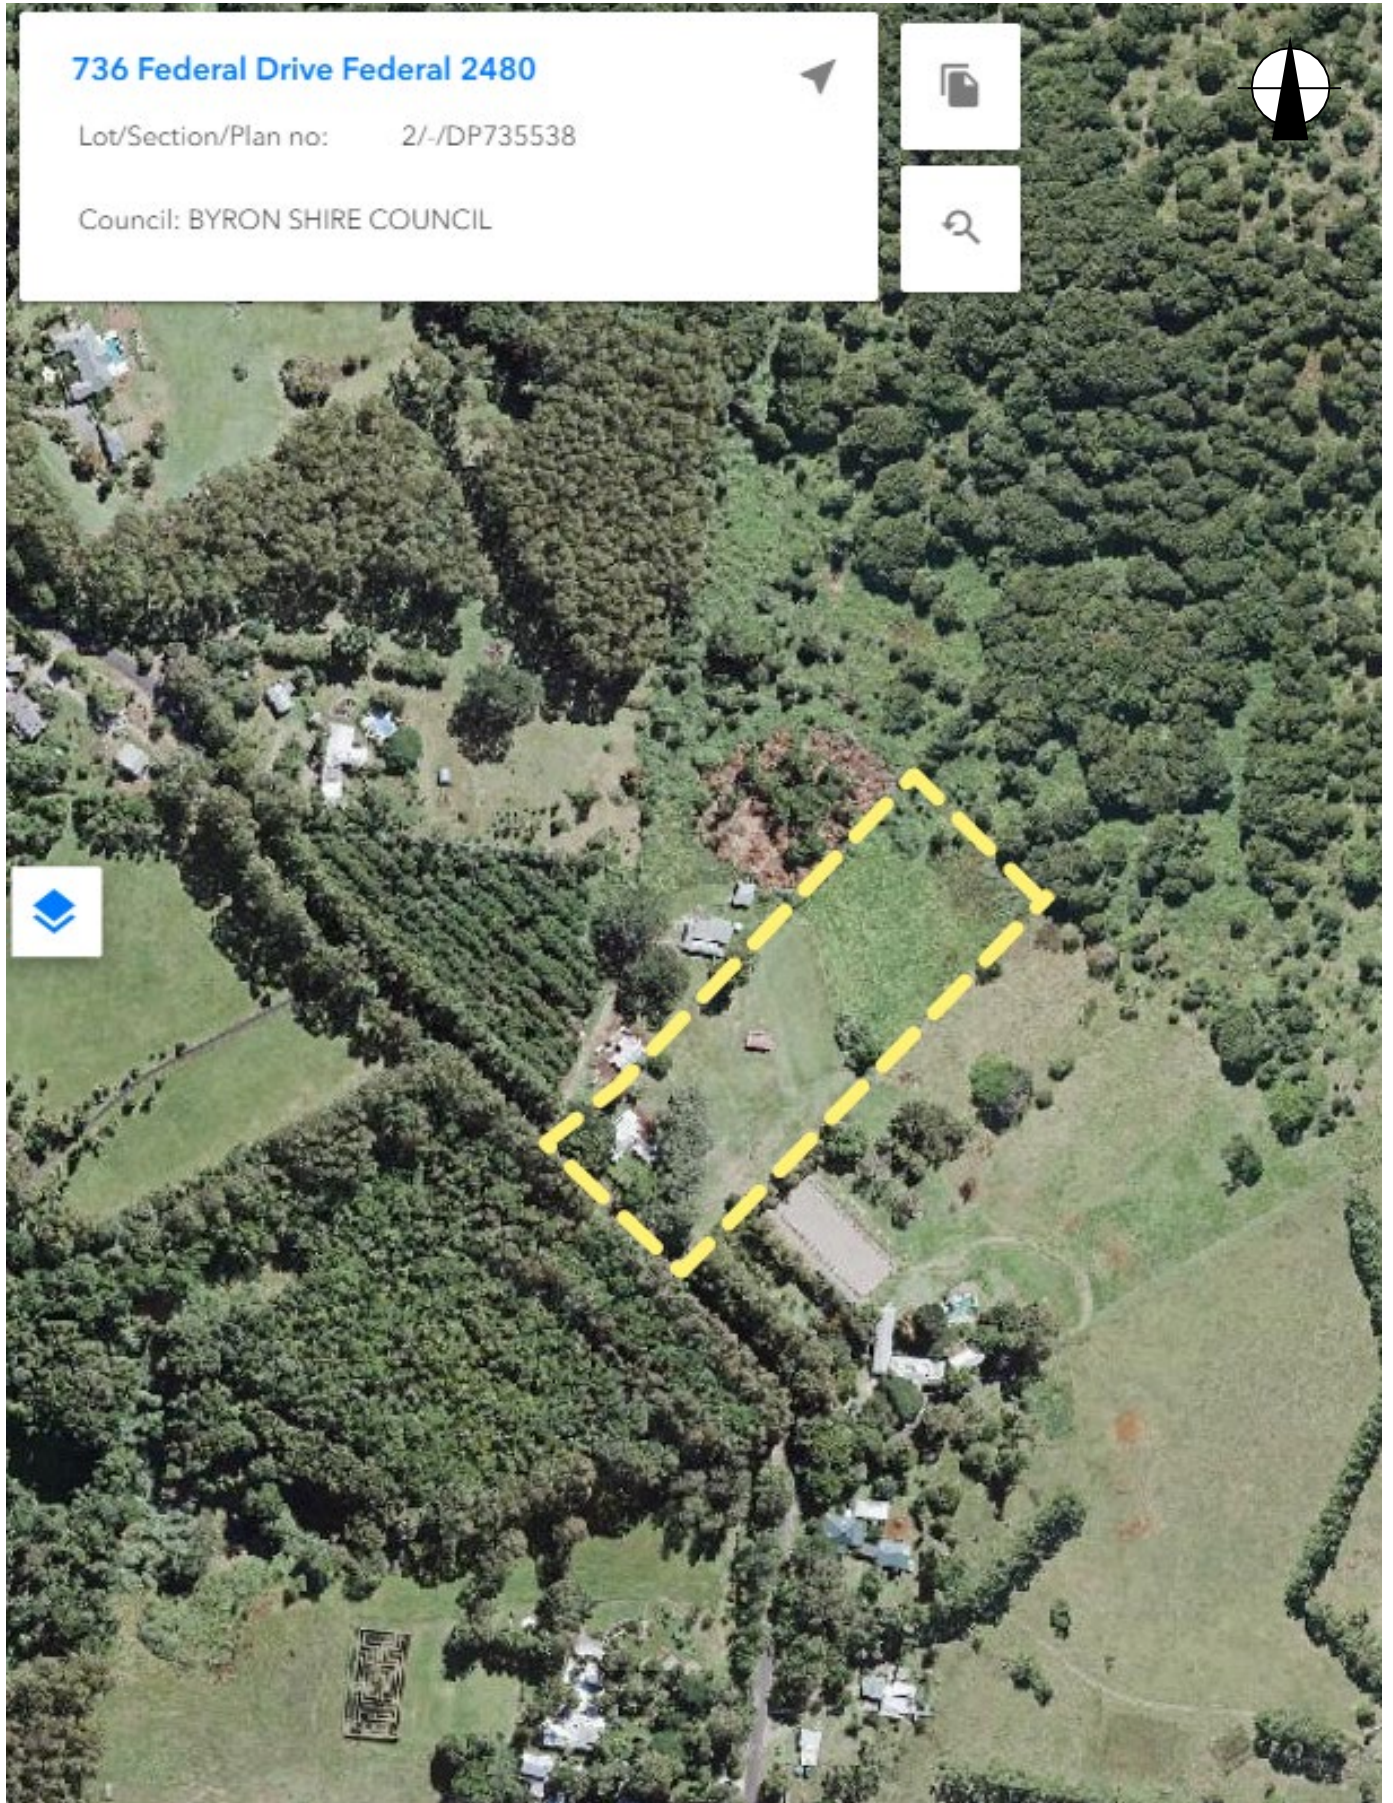
Source: <https://www.planningportal.nsw.gov.au>

This report presents the results of a geotechnical site investigation for three (3) new sheds at 736 Federal Drive, Federal, NSW 2480, described as Lot 2 on DP735538. The investigation was commissioned by email from Rob Rendell, on behalf of the owner, dated 15 July 2022, to complete this investigation. The commission was based on our fee proposal (Ref. P363 Federal), dated 15 July 2022. A Site Location Plan is presented as Figure 1.
